Analysis of errors in restoration of salty and damp walls

Wacław Brachaczek, Cezariusz Magott

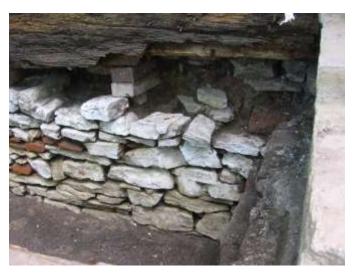
determination of the wall structure - an element necessary to examine the structure of the walls is performing drillings at different heights. In the past, brick was a relatively expensive material, far more expensive than it is now. The consequence was building 'beggar' walls in which the stem was made of less expensive materials. Bricks were only used for the facing wall layer. In the walls of historic buildings the very method of their construction, the type of material, and many centuries of effort caused the development of a variety of irregular voids, caverns and stretch marks. Test drillings may confirm the necessity of initial injections e.g. of low-shrinkage trass mortars in the divisions. This is the basic condition (both for pressure and non-pressure injection) for properly restoring the horizontal diaphragms. Low-pressure injections within the walls with voids result in a given standardized amount of injected product not filling properly the injection holes.

Figure 2. Appearance of the exposed foundation walls of different construction. $\,$

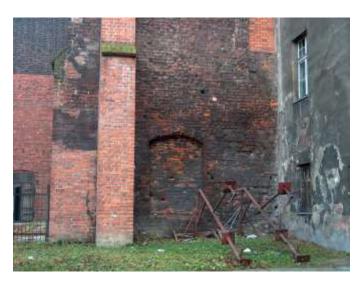
analysis of ground and water conditions - proper design of drainage around the building should be preceded by hydrogeological studies aimed at defining the water and soil conditions around the building. This investigation enables, among others, proper design of drainage around the object. In city centers, next to the existing historic buildings, new ones with highly developed underground part, intended e.g. for multi-level garages, are built. These buildings are designed

Fig. 3. Moisture level of the northern wall reaches approx. 5 m high above ground level - Museum in Raciborz.

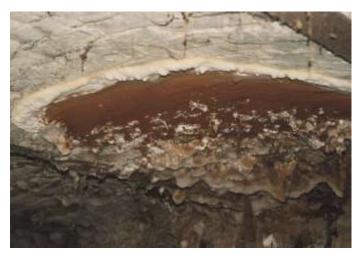
repairs involving the replacement of electrical installation. Grooves carved in renovating plasters were filled with gypsum mortar. After re-painting the walls, the whole installation layout was visible. A common mistake of the owners was also poor care for sufficient ventilation of rooms. In many cases, the air grates were veiled or blocked with furniture. Consequently, this has led to the emergence of the house or moldy fungus [12].

Fig. 5. The fruiting body of the house fungus proper (Serpulla lacrymans), grown into a vaulted ceiling of a basement room
