Wear Behaviour and Characteristics of Worn – out Valves used in LPG – run Retrofitted Gasoline Engines

[Pandey Ajay, Mandloi R. K.]

Abstract — Valves used in passenger car engines, running on gasoline, operate in a very hostile environment that is characterized by high temperatures and pressures, impact loading, thermal stresses, and fatigue loading. These engines, when in operation, result in generation of temperatures that are close to 600°C inside the intake valve; the corresponding value for the exhaust valve being 700°C to 800°C, respectively. However, the exhaust valve temperatures can shoot up to 950°C for a retrofitted LPG – run gasoline engine. Engine valves, being subjected to such high temperature and pressures, are extremely vulnerable against wear and consequent failure. Wear failure of valves is a commonly encountered phenomenon and the fatigue crack growth has its own role to play in contributing to the failure. The wear mechanisms in valves of LPG – run retrofitted engines have been found to be a combination of oxidation and adhesive wear, though valves also fail due to surface erosion and corrosion. Since retrofitting is a common practice in many developing count

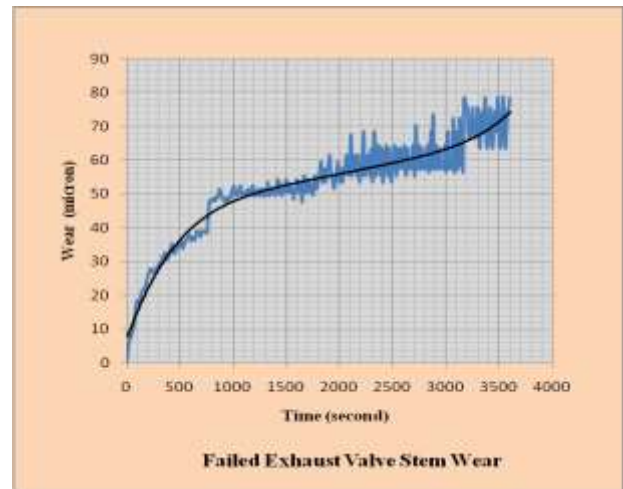
Figure 4 Wear variation curve for a failed exhaust valve stem

For a failed exhaust valve stem, the wear variation pattern is more regular and on predictable lines (Fig. 4). Its magnitude varies from 0.68 microns to 78.41 microns. The wear V/s time curve (Fig. 5) indicates that the stem is relatively softer than the disc and wears out consistently. As shown, wear varies from 0.72 microns (minimum) to 62.69 microns (maximum).

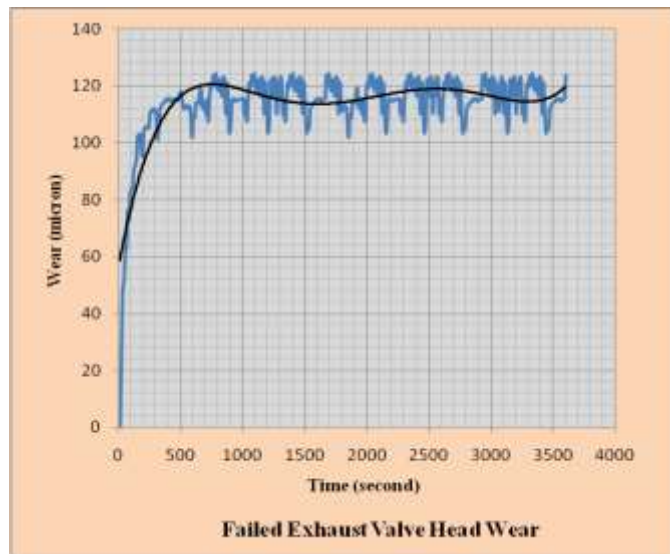
Figure 2 Wear variation curve for a failed exhaust valve head

The variation of wear with respect to time (Fig. 2) for a failed exhaust valve exhibits a definite similarity with oxidative wear mechanism. Corresponding to a particular load, the surface oxidation phenomenon is beneficial as it reduces the depletion of material. This is particularly true at high sliding speeds. The softened oxide film acts typically like a lubricant layer that protects the metallic substrate. The oxide films formed prevent direct metal - to - metal contact and also result in reduction in the coefficient of friction on contact surfaces, thereby reducing adhesive and deformation - controlled wear. The oxidation of material is closely linked to the existing operating temperatures and therefore is on expected lines as the exhaust valve in an LPG - run retrofitted gasoline engine usually encounters high temperature. However, the oxide layers formed on the material surface start wearing off with passage of time. The wear magnitude varies from a pretty low value of 0.39 microns to 124.41 microns as shown (Fig.2). The nature of the curve (Fig. 3) for a new exhaust valve head shows steady state wear after the initial zone of instability. The crests and troughs in this curve may be attributable to presence and sudden appearing of highly abrasive particles that raise or lift the pin on the POD tester, thereby creating sharp changes in wear magnitude. The magnitude of wear varies from a minimum value of 0.24 microns to a maximum value of 6.31 microns as is evident (Fig. 3).

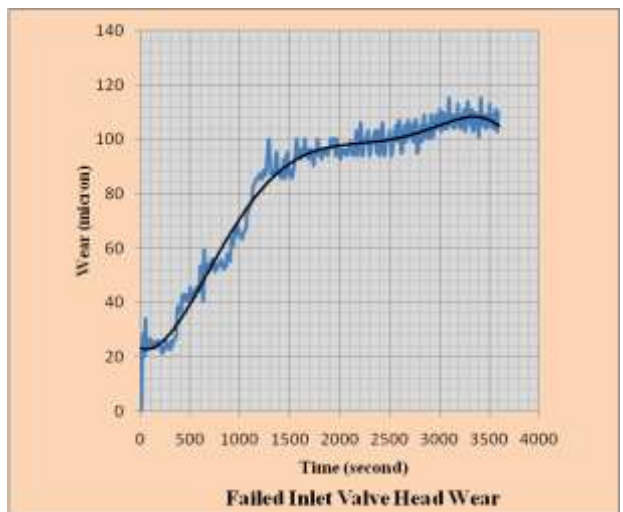
Figure 6 Wear variation curve for a failed inlet valve head

The variation of wear w. r. t. time for a failed inlet valve head is shown in Fig. 6. The variation reflects an almost steady wear condition with no noticeable abnormal behavior across any zone. The corresponding curve for a new inlet valve shown in Fig. 7 exhibits a wear pattern that is quite akin to adhesive wear.

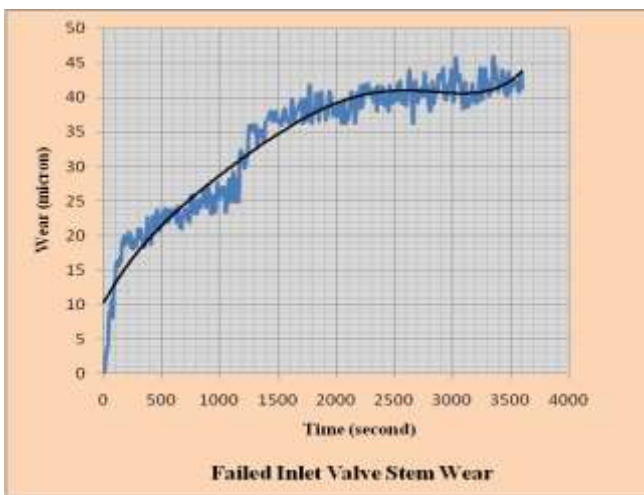
Figure 8 Wear variation curve for a failed inlet valve stem

For a failed inlet valve stem, the variation curve (Fig.8) shows removal of surface films with time and the building up of steady state wear whereas the corresponding one (Fig.9) for a new valve stem is characterized by adhesive wear, presence of surface particles / surface films, and graphite flakes.

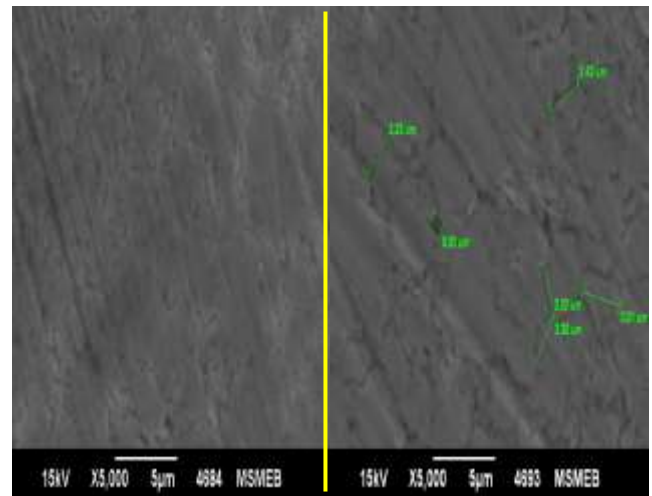
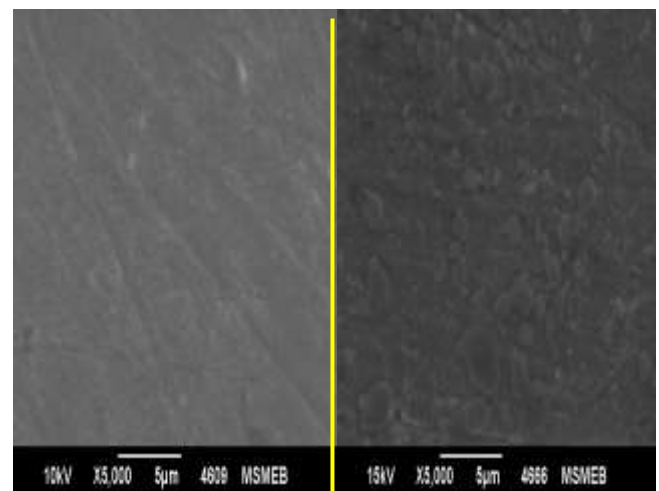
the presence of oxides whereas blackish grey patches indicate the presence of carbides in the valve material as also the effect of corrosion which becomes more pronounced at high temperatures. A fine distribution of carbides indicates increased material hardness but a coarse distribution of carbides makes them shift towards the grain boundaries with an accompanying reduction in the hardness and weakening of the material. The grain boundaries visible in the SEM image indicates that grains are broken and are not uniformly distributed. The size of grains, which is an indication of material strength, increases after working at high temperatures. Big size grains indicate lower strength whereas small size of grains (or finer grain sizes) indicates higher material strength. An increase in the size of the grains, or elongated grains, in SEM images of failed valves indicates that the valve material strength has come down after being subjected to high temperatures for considerable periods.

Figure 10 SEM image of a new exhaust valve head (left) and failed exhaust valve head (right) at X5000

Figure 11 SEM image of a new exhaust valve head (left) and failed exhaust valve head (right) at X5000

SEM images depicting the microstructure of new & failed intake & exhaust valves are shown at X5000 resolution (Fig. 10 & Fig. 11). The white colour spots in the images indicate
