# *Taoyuan Airport MRT EMU Vibration Prevention And Improvement Program Research*

**Abstract**—This study is based on the straight-line acceleration section and the occurrence of the jitter position on the operational routes, five sections are selected for the general survey, and then one section is selected for monitoring and analysis purposes. In addition, we try to find whether the corrugation phenomenon of the curved rail section affects the train or not?

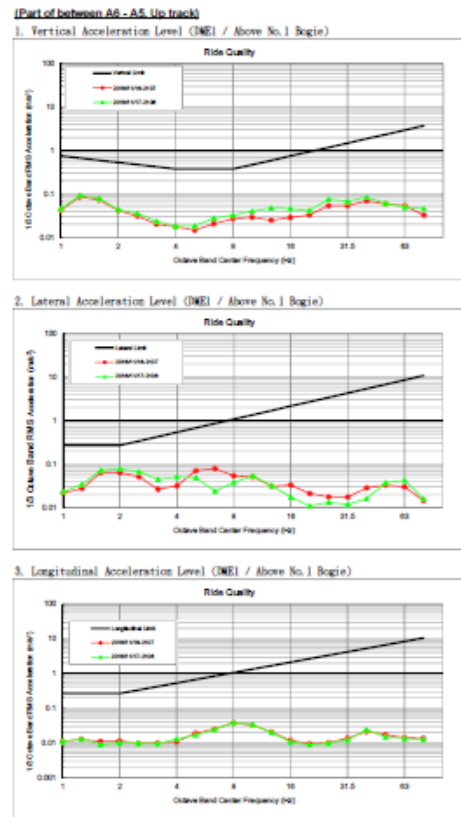
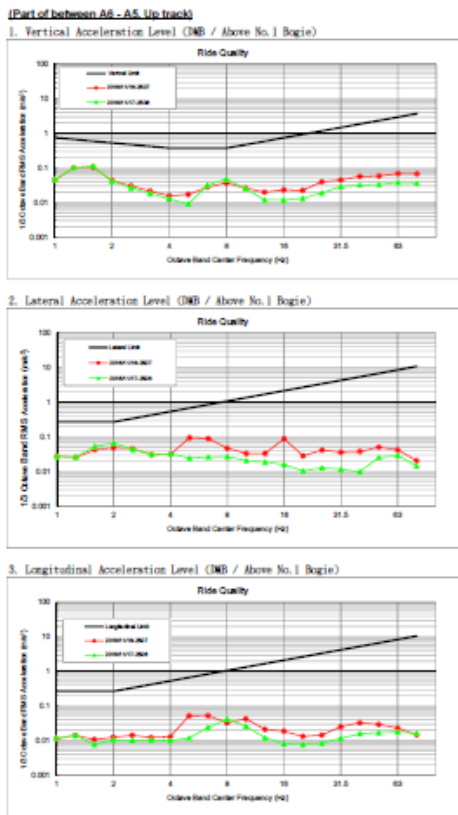
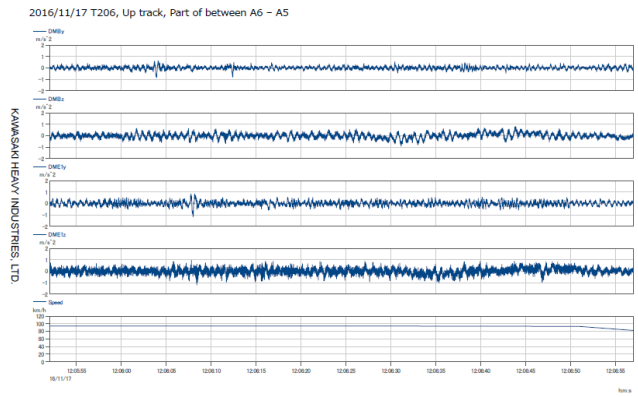
Table 3: The ride quality of the 2507 and 2506 on the A5-A6 upward track (DME1 + DMB)

As shown in Table 3, the ride quality of the 2507 and 2506 on the A5-A6 upward track (The ride quality) and Table 4 are the X, Y, and Z axis acceleration waves (train wave) and train speed.

Analysing the ride quality, XYZ axis acceleration wave, and train speed data curves, it was found that the experimental group and the control group had much greater jitters; the trains were returned to the main repair shop, and the trains in accordance with the above-mentioned steel wheels were used. Measurements, as shown in the photo in Figure 6, show the wheel treads of the DME1 and DMB of the T207 and T206. The T206 wears about 0.5 to 1.5 mm, and the T207 wears about 1.5 to 2.5 mm.

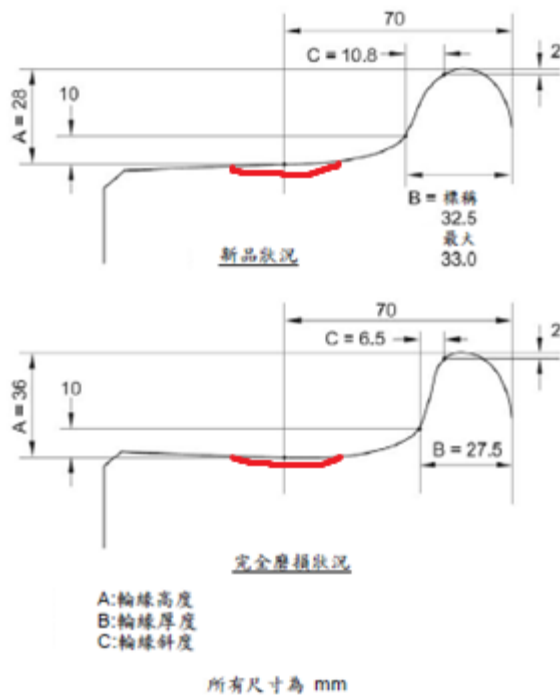
Figure 7: Concavity of wheel contour

After the measurement, it is found that the wear contour of the wheel contour is concave in the center, as indicated by the red line in Figure 7. The curve of the arc is not flat, and it is judged that the wheel turning error occurred as shown in Figure 7.

Because of this [6], the Taoyuan MRT route is tortuous, and the body is often deflected, which causes the wear arc of the steel wheel to be abnormal. In addition, during the turning process, the difference between the diameter of the steel wheel between the bogie and the bogie was ignored, and various factors caused the train to shake in the high-speed driving section. The flatness of the opposite rail tread will also affect the degree of wear of the steel wheel, so the damage of the steel wheel should be checked visually [7], as shown in Figure 8.

Taoyuan MRT's track and earth field inspected the top shape of the track tread in the high-speed section, especially the A6-A5 upward track. No correlation found in orbital wave wear. The vibration generated by the system is mainly caused by the excitation of the running wheels (Excitation)[6], which will affect vehicle speed, generate operating noise, cause train delays, and increase operations invisibly loss. Because it is a new operating route, do not neglect the work of track leveling. Track irregularity is the main source of excitation. Track leveling work should be done in time and early. The radian of the steel wheel exceeds the specified radian [4], the difference between the diameter of the steel wheel of the bogie and the bogie of the same car is too large [4], and the difference of the diameter of the steel wheel of the bogie of the car and the car is too large [4]. The train has begun the six-year inspection and overhaul phase, and the main suspension consumables such as bolster rod buffer rubber, axle box rod rubber, and spring seat should be replaced immediately if they are worn out. [9]
