# The Role of Thermography in the Non-Destructive Evaluation of Historical Architectural Surfaces

Some observations about the method and its purpose

[ Richard Ollig, Gaspare Massimo Ventimiglia ]

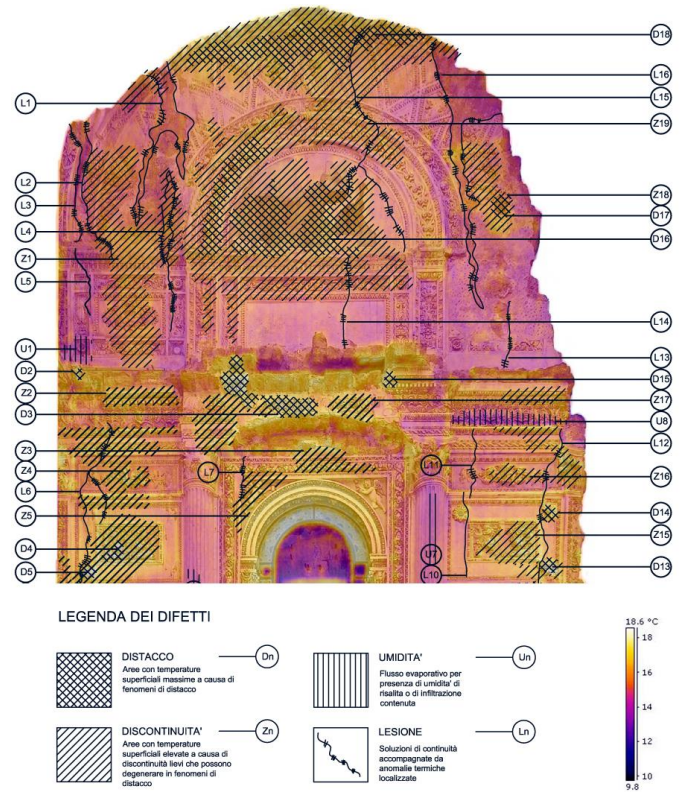
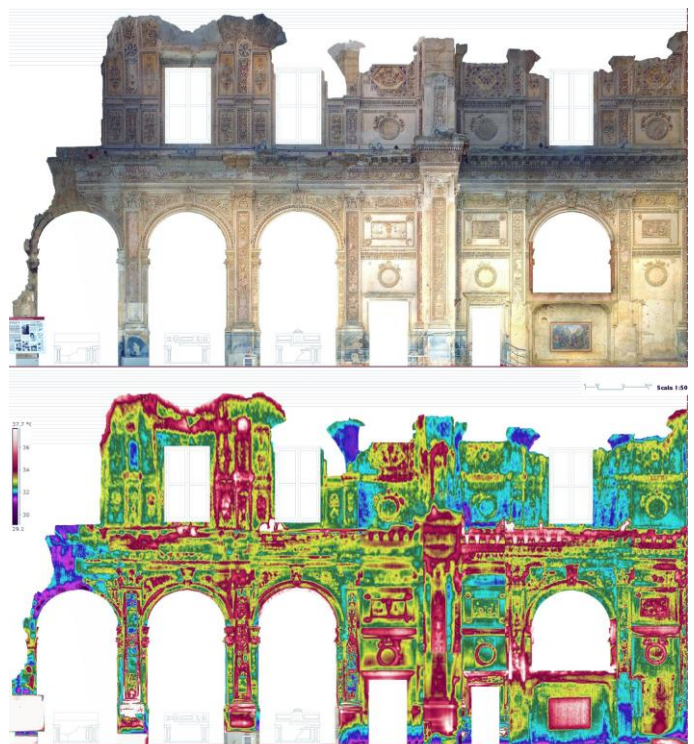
Figures 1-3. Santa Margherita di Belice (Agrigento), maps of the restoration project concerning the degradation analysis on thermal anomaly.

The computer processing of the thermal IR images has been developed in the laboratory and it was composed by some different phases, from the setting right of the infrared images to the elaboration of the thematic maps directly on the

thermal mosaic of images (Fig. 1-3). The result of the investigation achieves therefore a global character and becomes a thermal and metric image (in reduced proportions and measur-

able). From this phase the “measure” can be unified with the architectural mapping and acquire the potentiality to be integrated to the project too. The synergy between photogrammetric and thermographic survey and the fusion of their corresponding maps supported the clear demarcation of the detached superficial areas where consolidation was to be carefully accomplished. The thermal images were assembled or completely collaged upon the metric visible image in order to get the thermal (and simultaneously metric) maps of the stucco façades. The final result of the computer processing phases is a system of overlapped images, perfectly corresponding and without distortions.

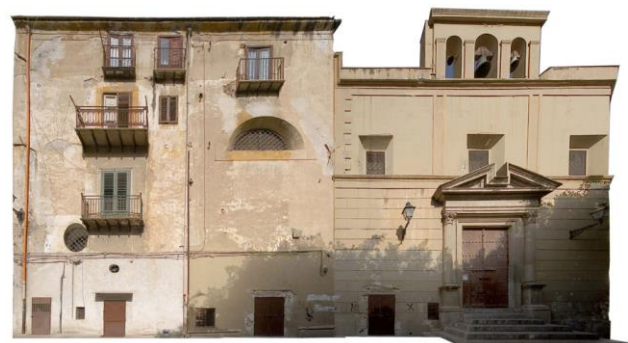
Figures 4-7. Palermo, San Giovanni dei Napoletani Church. Humidity phenomena (B), adherence loss and cavities (C, D).

The thermograms in different scales and variable transparency indicate humidity on the surface, which may have been caused by the eaves gutter. Another reason could be the inter-fusion of the humidity from the inside to the outside, where it evaporates. In the infrared picture the humid parts on the surface have the lowest temperatures and are shown in the darkest colours. The thermograms also show the extent of humidity in the whole lower area of the detail more clearly, which appears to be in good condition in the visual observation. There is also humidity near the gutter. In contrast flaking plaster, cavities

and non adherent plaster are most probably in the hot parts, which can be seen in the warm colours and the high temperatures. Non-adherent plaster and cavities act as thermal barriers. These non-intact areas are like failings, which have a lower thermal conductivity under the surface area. This is the reason why the surface above these areas keeps warmer longer, which can be seen in the thermogram in the warmest colours and hottest temperatures.

The application of preliminary studies by non destructive investigation in combination with the visual study generated some very interesting and utilizable results in the determination of the status and damage of plaster and masonry. The achieved results offer the opportunity to check specific areas, for later examinations for example by putting precise mini-bore holes into the plaster layers or into the masonry, also as the humidity measurement of the surface. To get a basis for the future procedures for later maintenance NDI can be helpful. In the field of historic research the investigation appeared structural alteration beneath the facing of plaster. Former semi-circular arcs between the windows, pilaster strips and jutties have been made visible due to the thermographic survey, because of the difference of the thermal conductivity of the materials.

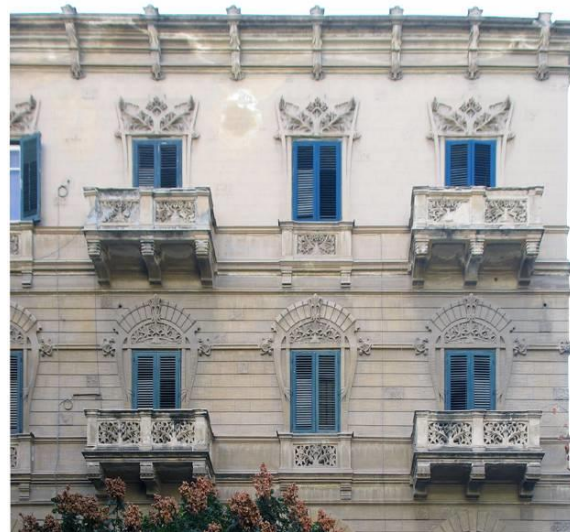
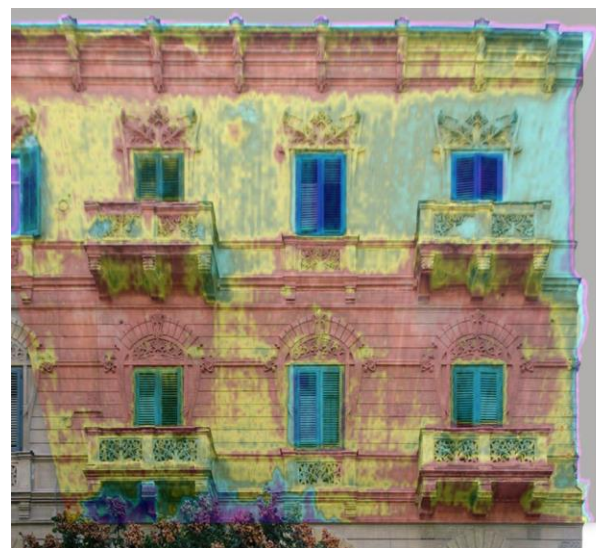
Figures 8-10. Palermo, Di Pisa Palace, the facade covered with artificial stone plaster; rectified photography and metric thermography highlighting areas characterized by higher emission levels (white areas).

A wide campaign of investigations by IRT has been recently carried out on the Art Nouveau architecture in the city of Palermo. La Casa Di Pisa, for example, is one of the most expressive Sicilian architecture of modernism, influenced by the school of the architect Ernesto Basile. The survey has allowed the visualization and localization of abnormalities in levels of adhesion, rather extensive and sometimes severe. Evaluating the graphs, diffuse thermal anomalies are observed, in particular, under the balconies of the last level, and slight discontinuity in the upper part of the façade (Fig. 8-10).
