# Diagnosis for Architectural Conservation

A synthetic report of a campaign of non-destructive and minimally invasive diagnostic tests performed in the church of Santa Maria delle Stelle in Comiso (Ragusa, Sicily)

[ Gaspare Massimo Ventimiglia ]

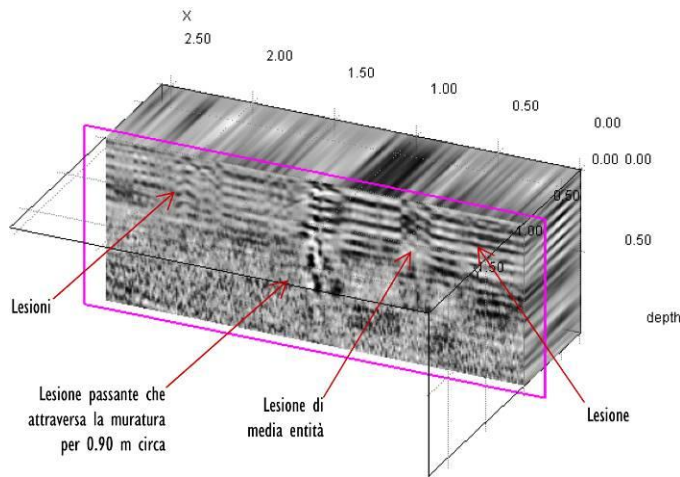
Figure 5. Volume of three-dimensional electromagnetic reflections in which the fractures within the masonry are made evident.

The radar scans show some defects found through the investigation, as small cavity that generates simple and recognizable hyperbolic reflections, system of small cavity highlighted by irregular reflections and crossed hyperbole, compact section with the absence of electromagnetic reflections, discontinuity or lesion characterized by a system of reflections oriented towards specific directions, presence of humidity that involves the absorption of electromagnetic waves, and defects in adhesion between layers recognizable through the localization of layered reflections (fig. 5-6).

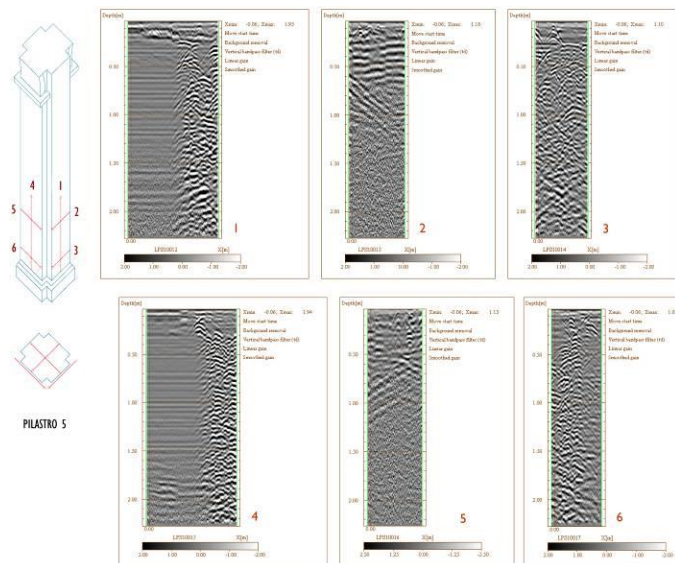
Figure 6. The base and the pillar show the reflections of the signal demonstrating different levels of compactness.

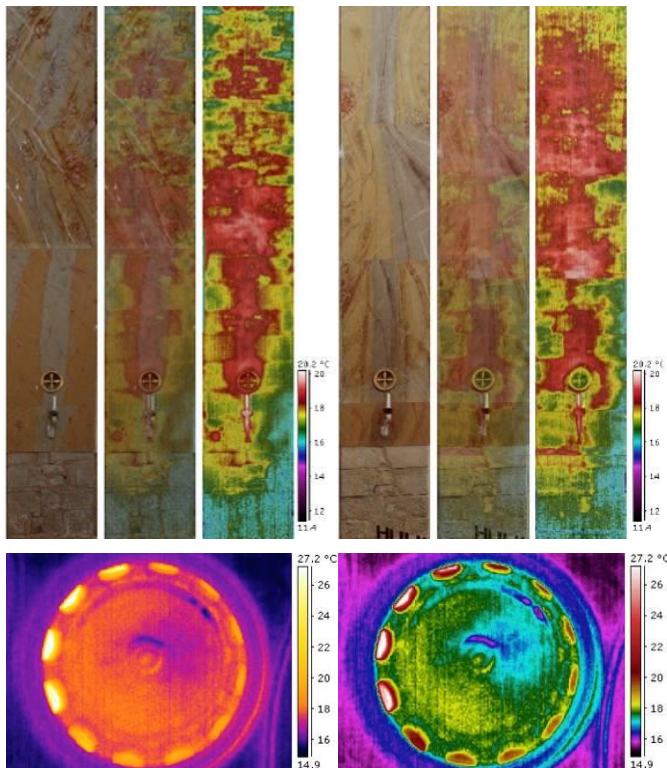
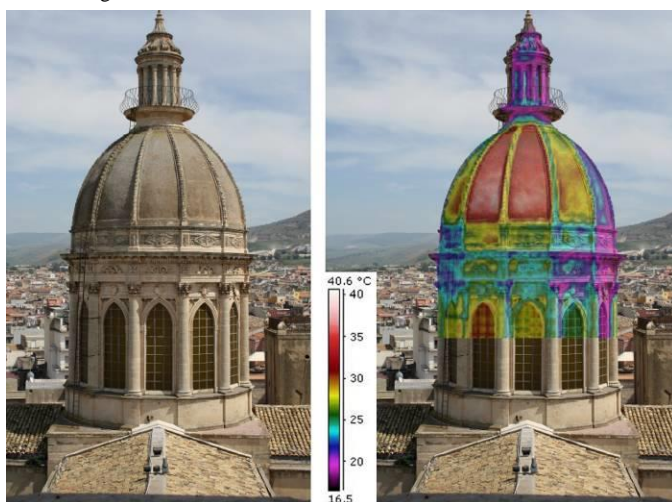
Figures 7-12. Thermographic survey carried out on the artificial marble coating and on the internal and external surfaces of the central dome.

The thermography in “active method” was used to investigate the inner surfaces of the church (artificial marble on pillars, interior of the dome): it measures the temperature reached by the surfaces as a result of overheating due to a source of artificial heat (one or two fan heaters with hot air flow of 650 cubic meters per hour) and is optimal for the non-destructive monitoring of the degradation phenomena on finishing surfaces (fig. 7-10). The thermographic survey of the plaster and the exterior surfaces of the dome was carried out after the rise in temperature induced by sunshine during the day (fig. 11-12). The graphical representation of the spatial distribution of thermal levels and the control of its variation in time, allow detecting defects in the structure of the material, which cause locally alterations of thermo-physical properties. The thermographic method is then targeted to the location of defects in adhesion of the surface layers and humidity caused by phenomena of capillary ascension or infiltration.

In order to support the analysis of moisture, the colder areas because of the evaporation process in progress can be highlighted and the extent of the phenomenon can be seen. Wet areas are visible because they clearly correspond to colder

areas and the path of the water in materials is emphasized. The digital thermograms were then processed with the use of specific set of software: to make an accurate analysis of the infra-red images, each thermogram was returned by mosaicking on the visible rectified image of the surface, without the perspective distortion. The final maps are therefore metric mapping of surface temperature distribution, which support useful and rigorous diagnostic assessments. The colour tone of the final graphics are obtained by combining the scale of the temperature measured at the surface to a scale of false colours, thus obtaining an interpretative model of the state of conservation that allows you to identify, with precision, the anomalies in the more superficial layers of coating.

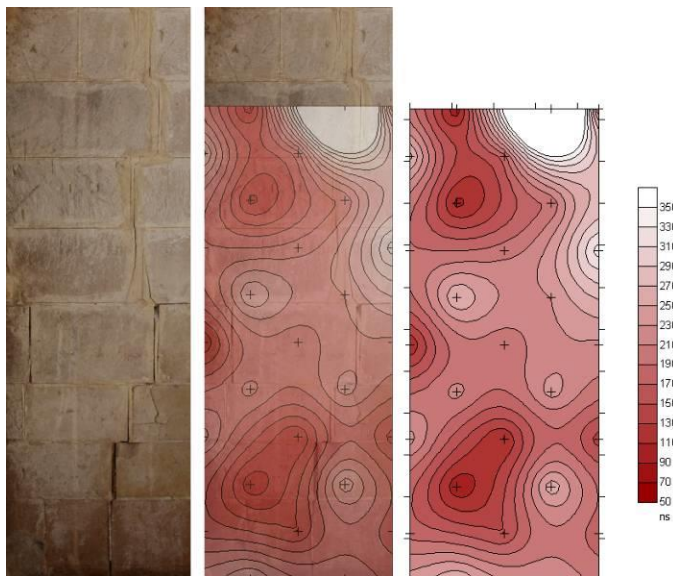
Figure 13. A lesion in the wall near the entrance central portal. Ultrasonic tomography processed with the measurements of pulse propagation time between the probes.

The types of probes used during the investigation were selected according to the thickness of the walls to be investigated. Recording the speed of propagation along a square mesh grid, the ultrasonic tomography has been developed. The measurements are shown in the graphs and the areas with defects have lower speeds of micro-seismic waves and increased transit times (fig. 13).

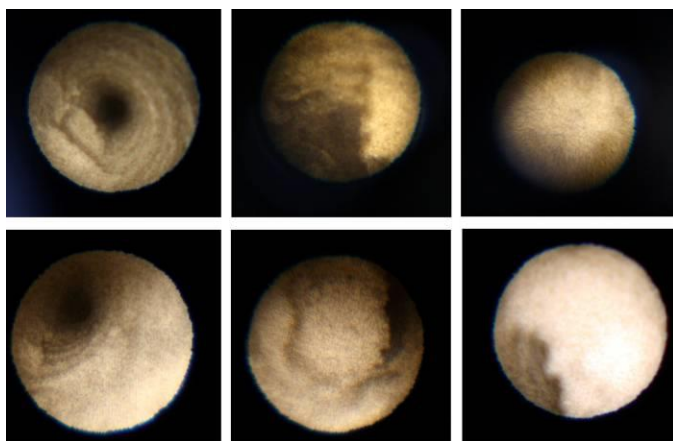
Figure 14. Observations inside the masonry (squared blocks of Comiso stone linked with lime mortar) made with a optical fiber endoscope.

To improve the graphics performance of images, characterized by high radiometric contrast areas, the camera was set to a nominal sensitivity of ISO 800 with very low contrast values. The assessment of exposure was estimated through the camera's internal exposure meter (TTL) using a sensitivity of -0.5 EV on an evaluation matrix system. The sharpness is improved by placing the camera to focus on the macro setting and using the appropriate ring of light scope. Some limitations are however perceived during the test: the first is the inspection of limited portions of the inner surface, the second is the background noise caused by the optical fibbers. Despite the limitations of endoscopy, inspection of internal parts has provided important information to refine the analysis of the crack (fig. 14).
