# Potentials of ground penetrating radar for the assessment of outer stone masonry leaves

Charles Bridge in Prague

Jan Válek, Jakub Havlín, Monika Slavíková

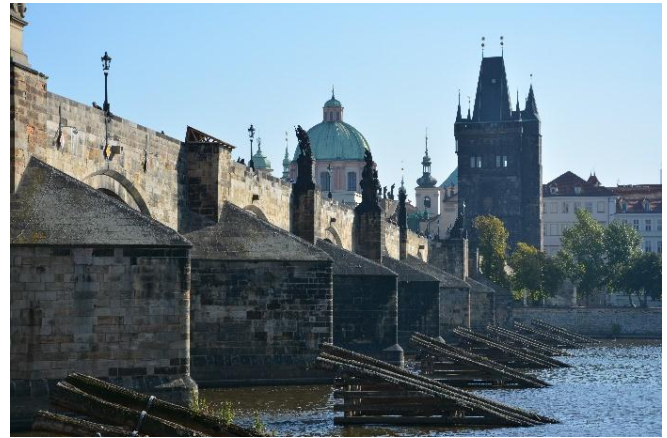
Figure 1. The south side of the Charles Bridge in Prague

The construction of the Charles Bridge in Prague begun in 1357 and it replaced an older bridge (Judith Bridge) which was severely damaged by a flood in 1342. It takes its name after the king Charles IV who ordered its construction and who largely initiated and supported the development of mediaeval Prague and the Czech kingdom of that time. Nowadays, it is a prominent structure of a great cultural heritage significance in Europe and it is protected as a national monument. Throughout the history, it was several times badly damaged by floods and the structure was consequently several times reconstructed.

The Charles Bridge itself is 621 m long and about 10 m wide with 16 archers crossing the river Vltava. The structure is a typically medieval stone masonry with massive piers and vaults. The outer masonry is made of sandstone blocks bonded with the rest of inner solid masonry made of a rubble units and lime mortar [1]. The stone masonry have been exposed to relatively harsh weathering conditions for a long time and deterioration occurred mainly due to elevated moisture content in combination with freeze-thaw cycling and due to presence of salts and their crystallization pressure. The sandstone masonry of the piers is additionally exposed to an elevated moisture content and forces caused by the current of the river at the water level and below.

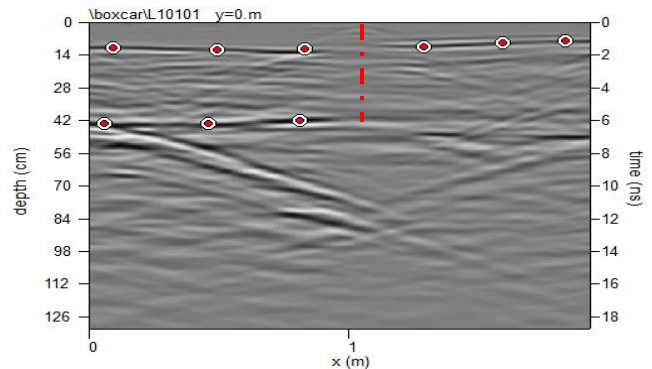
Figure 3. A radargram taken in the middle of the block. The dots mark points at which the depth was determined to calculate precision of such reading. The first layer – facing stone, the second layer – end of block.

Initially, larger stone masonry blocks which were withdrawn from the bridge during previous repairs were assessed to evaluate the method with a possibility to examine also the inner structure that was partially visible. An example from this initial measurement is given for a stone block No. 133 composed of original Žehrovice sandstone and two replacement stones (Božanov sandstone) cemented with an adhesive mortar, see the drawing on Figure 2. The radargrams are presented on Figure 3. The thickness of the first stone slab is clearly visible and identifiable by the reflected signal from the interface sandstone božanov – cement grouting. However, the next interface grouting – sandstone (Žehrovice), was not identifiable. The last reflection is from the end of the block. However, the cement based grouting attenuated the signal differently along the scan.

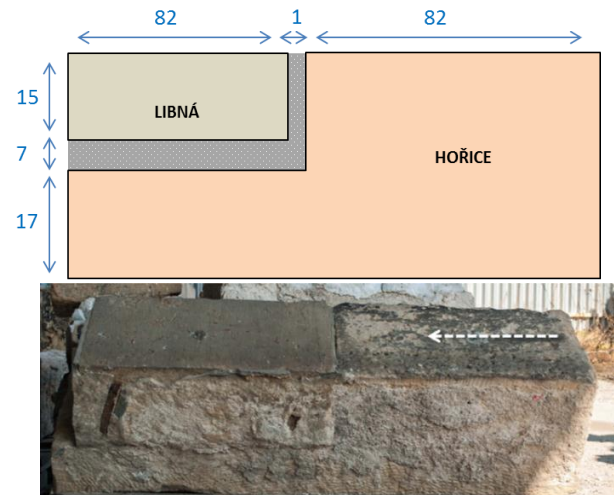
Figure 4. Dimensions and photo of the assessed block No. 82VA. The white arrow is the direction of scan taken.

Another example is a block No. 82VA. In this case a decayed part of the original block (Hořice sandstone) was replaced by a new piece of Libná sandstone, see figure 4. The radargram on figure 5 shows reflection at the end of the Hořice sandstone block. However, both Libná sandstone and the cement based grouting caused attenuation of the signal. The interface between the Libná sandstone and the grouting is possible to determine but the reflection is relatively weak. Moreover, there is a reflection artefact on the right hand side which is not accompanied by hyperbolic reflections.

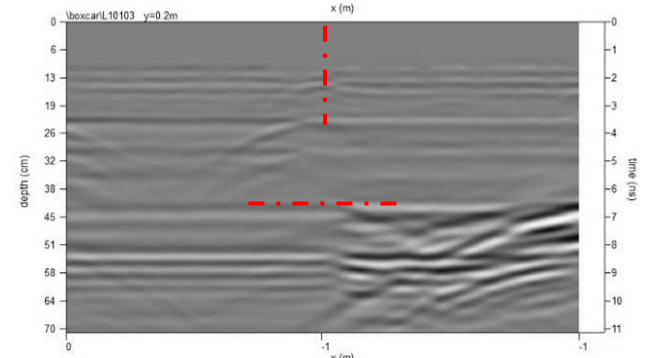
Figure 5. A radargram taken in the middle of the block 82VA.

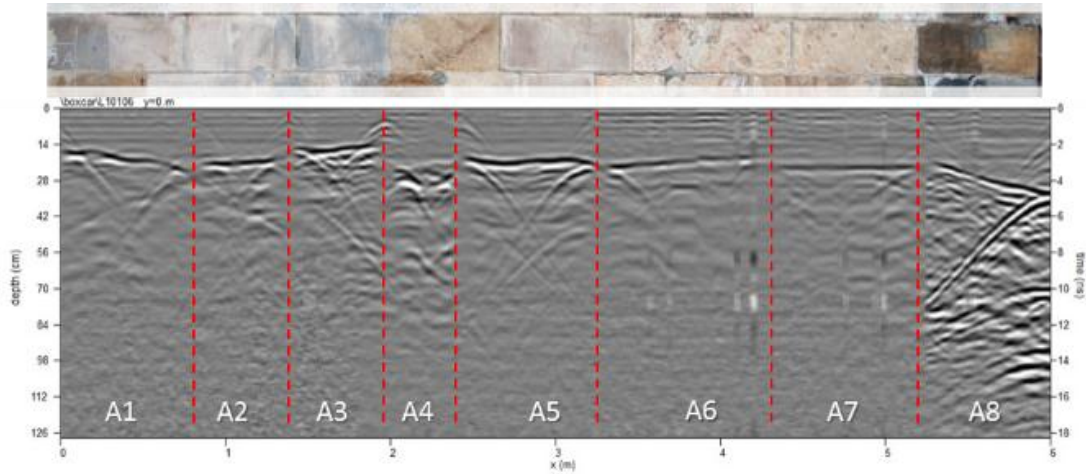
facing stone							stone
Depth [cm]	15-17	19-18	13-14	22	17-18	18-19	20	20-30

Figure 7. A representative GPR scan of the masonry layer A.

A typical scan representing the assessment of the masonry layer marked A is presented on Fig. 7. In this case the GPR assessment identified well the thickness of the stone units. The depth of the reflection from the end of stone interface is about 15-20 cm and it suggests that these stone units are only facing stones that replaced the larger (deeper) historic ones. All of them are probably well connected with the masonry behind and there is no reflection that would suggest the ends of original stone blocks. This is probably due to the attenuation of the grouting mortar behind the blocks. Potentially less well bonded are stone units marked as A3, 4 and 5. However, there is no larger void producing a repetitive reflection of the signal. The corner stone A8 does not have a rectangle shape and its rear side is widening towards the corner. The shape of the reflection corresponds to the rear side. This means that units A6 and 7 are relatively regularly cut blocks as opposite to e.g. unit A1 and A4 with rather rough rear surface.

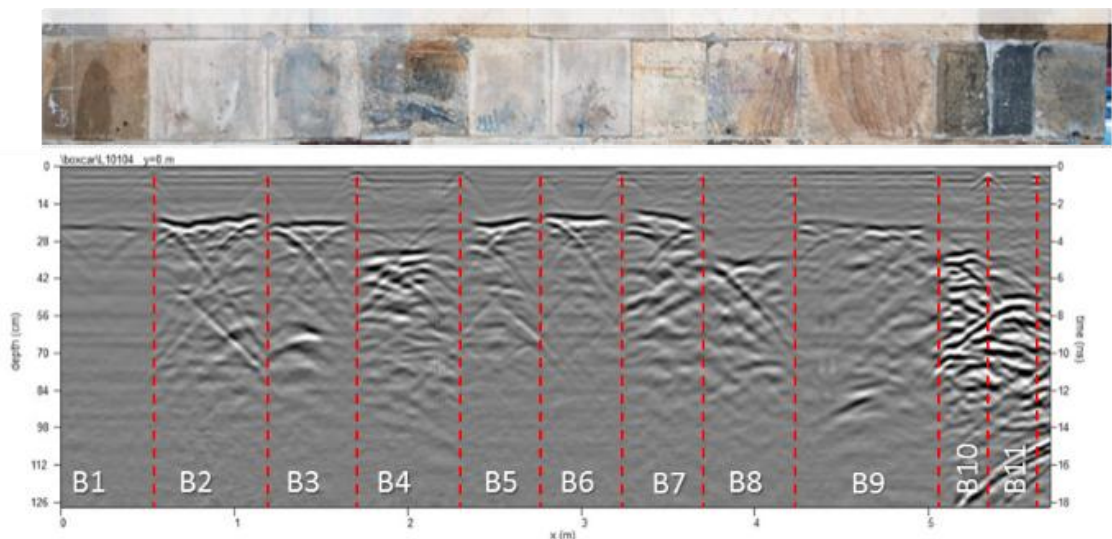
facing stone		stone	facing stone			stone	facing stone	stone		
Depth [cm]	18	16-18	18	30	18-19	16	15-17	31	18-20	30	46

Figure 8. A representative GPR scan of the masonry layer B.

The GPR assessment of masonry layer B is presented on Fig. 8. Similarly to the layer above (A) there are reflections at the depth of 15-20 cm which is attributed to newer facing stones. Original stone depth is assumed to be around 30 cm (B4 and B8) with occasional larger bonding stones. Stone unite B1 caused exceptionally high attenuation of the signal. Deeper reflections are not forming any clear pattern to allow interpretation regarding the structural morphology of the masonry.

They could be associated with a certain inhomogeneities of masonry like larger stone blocks (B2, 3, 8 have reflections around 60-75 cm) or possibly also metallic objects (B11 – hyperbolic reflection). Irregular reflections behind the blocks B4, 7 and 8 suggests rubble stone masonry. The reflections near the corner can be interpreted as irregular inhomogeneous rubble masonry.

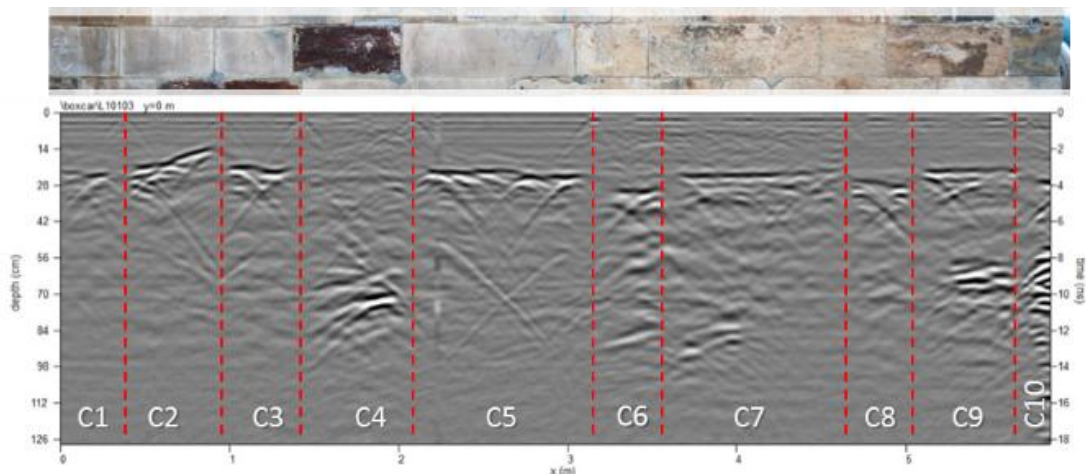
facing stone		stone	facing stone			facing stone		
Depth [cm]	22	12-19	18-20	60-61	21-22	29	21	24-26	20

Figure 9. A representative GPR scan of the masonry layer C.

A typical scan representing the assessment of the layer C is presented on Fig. 9. The reflections at the depth of 15-20 cm are attributed to the replaced facing stones. Unit C4 is probably one of the remaining older blocks that reaches the depth of 60 cm. Reflection at this depth is also noted for stone unite C9. The hyperbolic reflections behind the block C5 can be interpreted as several stone units (perhaps the joints of the historic masonry blocks) or possibly also metallic objects.
