Thaumasite Formation in a Newly Built Concrete Structure in Northeastern Algeria

Abstract: Severe damages such as expansion, cracking, spalling, have been observed in a public facility (communal library) recently built in the northeastern region of Algeria. Microstructural examination of the concrete samples extracted from different structural elements revealed an abundant presence of thaumasite in association with ettringite and/or gypsum. The thaumasite was found within cavities at the interfaces aggregates/cement as well as in the high dolomitic cement matrix. The deterioration of the concrete studied was attributed to the thaumasite sulphate attack (TSA) supported by the alkali dolomite reaction (ADR). With regard to the semi-arid nature of Algerian climate, it appears that the condition of low temperature (less than 5 ° C) required for the formation of thaumasite reported in the literature seems to be not necessarily true.

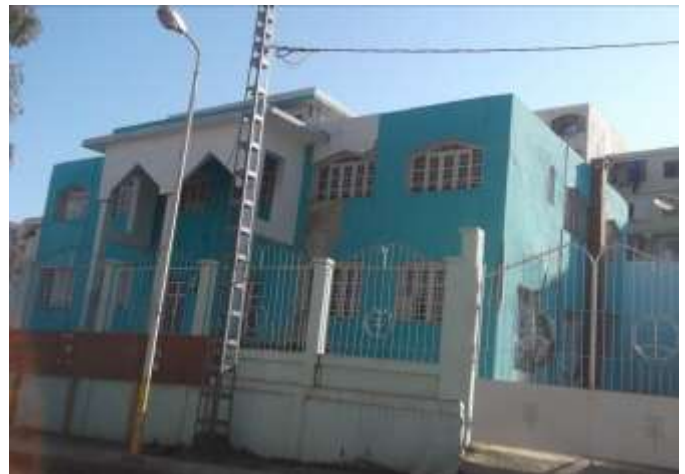
The damaged building investigated was a public facility (communal library) constructed using reinforced concrete, Fig 1. This structure was built during the period 2005-2007 in an important urban area, located in north eastern part of Algeria.

Fig. 1. Damaged public facility in northeastern of Algeria,

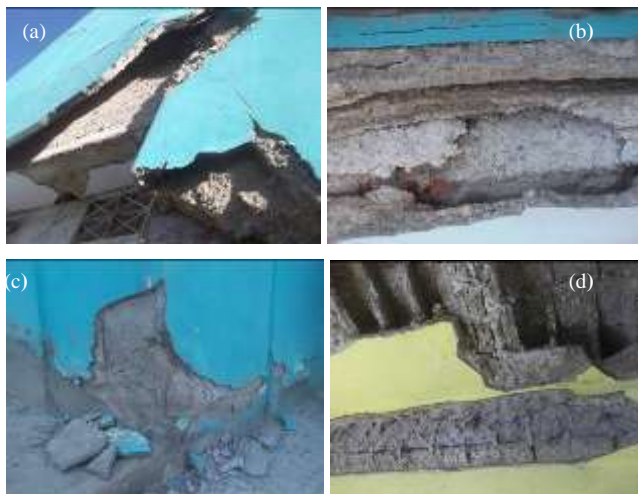
The visual observation conducted revealed various damages such as expansion, cracks, spalling etc., affecting the concrete and mortar, as shown by the Fig. 3 (a, b, c and d) below. These damages include sub-parallel cracks filled with white haloes occurring around aggregate pieces and sometimes cement paste matrix transformed into a mush. The observed damage phenomena have attributed to the sulfate attack associated with the alkali dolomite reaction.

Fig. 3. Damages observed in situ: a) cracks and large expansion of mortar; b) concrete spalling with white coating; c) expansion of concrete and materials loss; d) concrete transformed into mush

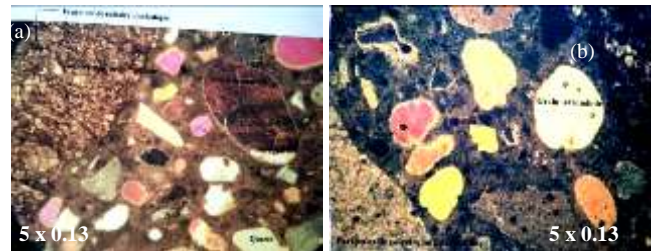
The microscopic observation on thin sections showed large pores and voids abundantly distributed in the dolomitic paste, Fig 4 (a and b). Petrographic analyses of the thin sections revealed clearly the thaumasite deposits present in association with gypsum and ettringite. The thaumasite bands were concentrated in isolated areas of the cement paste and the paste-aggregate transition zone. Some of them passed through the siliceous aggregate particles. The source of carbonate for thaumasite formation was probably calcite due to the carbonation of the cement paste or carbonate ions in the ground water and certainly the very low carbonate aggregate.

Fig. 4. Dolomitic cement matrix contain thaumasite deposits present in association with gypsum and ettringite

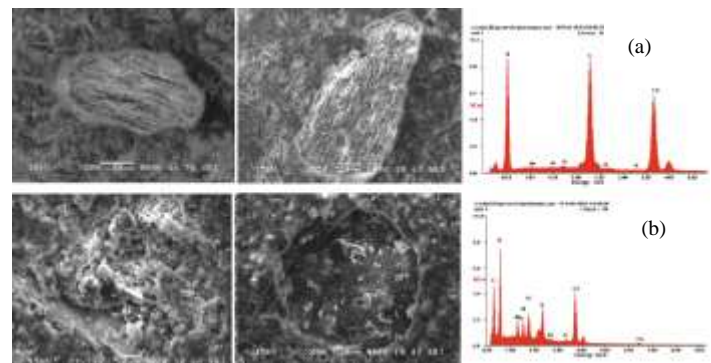
The Fig. 5 illustrates an SEM micrograph of the concrete, in which there are large amounts of needle-like crystals. According to the traditional theory of sulfate attack in cementitious materials, the needle-like crystals should be ettringite associated with gypsum.

Fig. 5. SEM photograph of ettringite and thaumasite formation on the concrete communal library structure; (a) abundance presence of gypsum ; (b) the EDS spectrum shows that the height peaks for Si, S, Ca and Al, typical for thaumasite presence

However, it should be noted that the ettringite crystals normally should contain Al^{3+} in it, but the EDS analysis conducted showed that the product includes also Ca, S and Si, and Al. Therefore, the crystals are not expected only to be ettringite. In our case, beside ettringite, gypsum was also observed, as shown in Fig 5. This could explain the high concentration of sulfate solutions in the sample analyzed, [20]. In the micro-observations, gypsum was formed initially since
