Review and a validation project on delayed Ettringite degradation during mass concreting

K S Ang, Z H Chew, S C Fan*

K S Ang, Z H Chew, S C Fan*
School of Civil & Environmental Engineering
Nanyang Technological University, Singapore

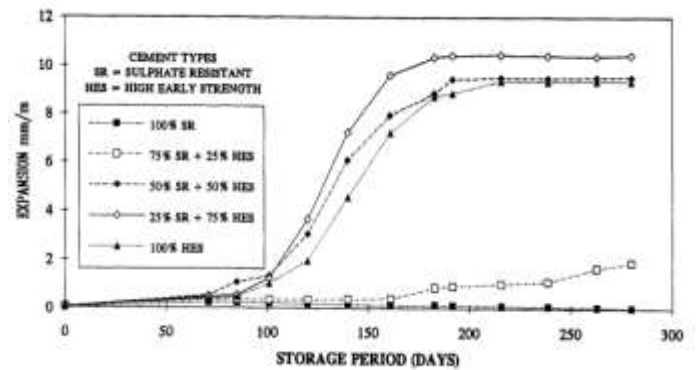
Figure 1: Examples of Various Mortars after Heat Treatment (Ghorab et al. [8])

In a second series of experiments, specimens were subjected to a 1-day delay period followed by 1.5 days at 80°C and then a 6-hour temperature rise to 100°C; immediate cooling then followed, causing the specimens to reach maximum temperature. Fig. 1 shows the expansion of bars which were manufactured based on different blends of sulphate-resistant (SR) and high-early-strength (HES) cements. Blends which contained more than 25% high-early-strength cement have shown substantial expansions which starts after soaking in water for 70 days.

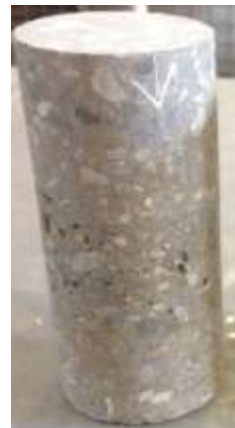
Figure 9: Cylindrical Sample

Compressive strength test was carried to investigate whether there is degradation in strength in association of the presence of Ettringite formation. The sample size is 100 mm in diameter and 200 mm high as shown in Fig. 9. The moment at failure is captured in Fig. 10, and the crushed sample is shown in Fig. 11. The compressive strength of 39.6 N/mm² for a specimen from core sample (labelled 2.1-2) was registered.

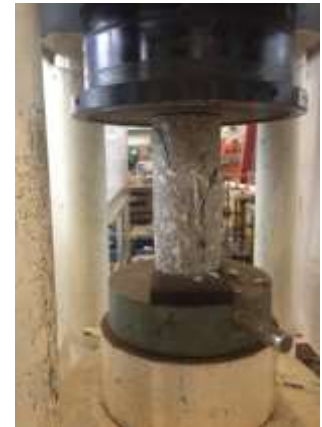
Figure 10: Compressive Test

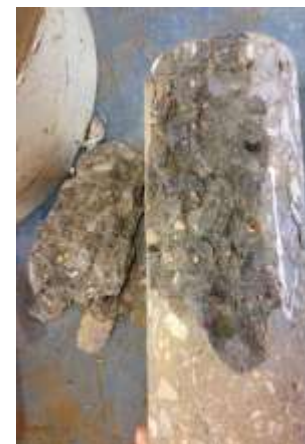
Figure 11: Crashed Sample
