# *Deterioration patterns of building limestone in the Septimius Severus family Temple in the Roman ruins of Djemila (Algeria)*

[NaïmaTouloum, Ahmed Brara]

**Abstract**— The Roman ruins of Djemila (Cuicul) provide a typical example for limestone weathering in semi-arid and continental climate. Investigations on the Septimius Severus family temple located in this antic city are conducted, with the aim to determine the mechanisms of the major decay patterns of building limestone. The role of both intrinsic factors (limestone petrography, and porosity) and environmental factors (moisture variation, thermal gradient) are studied. The investigations demonstrate that the weathering process is mainly triggered by rain-dry cycles combined with thermal gradient.

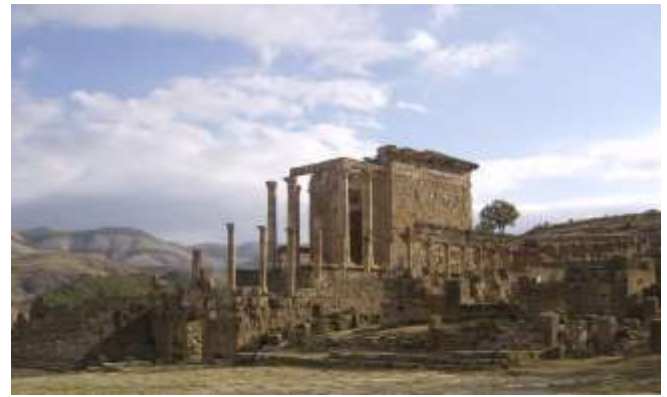
**Figure 3. Septimius Severus family Temple**

Around the beginning of the 3<sup>rd</sup> century, the city of Cuicul expanded beyond its ramparts with the creation of the Septimius Severus Temple, Figure 3.

The visual inspection revealed that different dimensions of masonry elements were used as construction units. The stone masonry elements suffer from a concentration of damages in the top of the walls and columns of the temple, as shown on Figure 3 above. The concentration of damage results visibly from stagnant rainwater and snow of the cold seasons. From the top to the bottom, rainwater slowly penetrates downward by capillary suction or seeps by gravity into the masonry stones. At the same time, the water penetrates into the adjacent columns and walls by capillary rise. Between the single rain events and in subsequent dry season it evaporates again mainly over the vertical stone surfaces of the bases exposed to sun and wind. The degradations listed are essentially material loss, cracks, contour scaling and biological deposits.

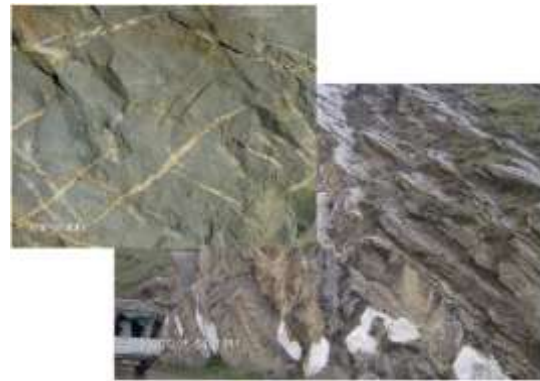
**Figure 4. The hard gray veined limestone with calcite extracted locally**

The most material used in the construction of the Septimius Severus family Temple is a hard gray veined limestone with calcite. This stone is characterized by a large vein (streak) of calcite, extracted locally, and commonly called micritic limestone, Figure 4.

The macroscopic and microscopic observations of this stone showed an heterogeneous structure and the presence of veins of calcite. According to the mineralogical analysis with XRD, this gray limestone is principally composed of calcite with some quartz. This stone characterized by a very negligible total porosity (<1%) and very fine pores size. In relation to the climate nature of the region, the linear expansion coefficient of the stone used was determined in the laboratory using the high temperature dilatometer. The obtained thermal expansion coefficients  $\alpha$  for the vein, matrix and matrix + vein parts of the rock are respectively  $\alpha_v = 3.9 \cdot 10^{-6} \text{ K}^{-1}$ ,  $\alpha_{m+v} = 2.4 \cdot 10^{-6} \text{ K}^{-1}$ ,  $\alpha_m = 2.2 \cdot 10^{-6} \text{ K}^{-1}$ .

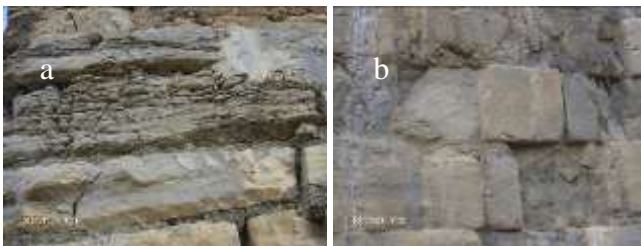
**Figure 5. Cracks and material loss**

The detachment and loss of stone material were observed mainly on the stone surfaces of the elements, subjected to temperature variation combined with dry and humid cycles. These deterioration patterns are the most observed on the temple compared to the other patterns, [7].

Daily and seasonal fluctuations of ambient temperature create climate cycles that can cause alteration of the stone. It is known that limestone is especially vulnerable to repeated moisture changes and temperature variation [8]. It is admitted that a change in temperature always corresponds to a volume change. When the temperature gradient repeated with a given frequency, it may decrease the intrinsic characteristics of stone materials by anisotropic thermal expansion. Principally the mineral of calcite that has a large anisotropy of thermal expansion composes the limestone studied. Moreover in the case of the studied limestone, this expansion is high the vein of calcite compared to the matrix of the stone. The result is a warm up repeatedly shattered the intergranular spaces grains of calcite. Furthermore, dilatation and contraction during wetting/drying in parts of the structural elements of the temple cause stresses in the limestone structure, resulting in material fatigue indicated by cracks and material loss in the end as shown on Figure (5) a and (b).

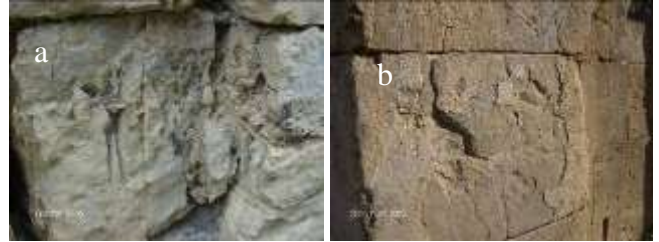
**Figure 6. Erosion and contour scaling**

Erosion and contour scaling (Figure 6, a and b) of the veined limestone are the second most common type of damage observed at the temple. These patterns are frequently occurring in parts of the temple elements intensively wetted from the surface during the rainy season. They are due in one hand to the dynamic change of water saturation of the veined limestone surface during and after rain events and the subsequent wetting and drying behavior. Here in the temple, the mechanism of contour scaling may also work without any salt loading (because the site is situated in rural area), only driven by moisture changes, [9].

On the other hand, the temperature on the surface is higher than deeper parts of the stone, which causes thermal

dilatation. This will cause shearing stresses in the transition zone from the surface and the deeper parts of the limestone. The absorption of radiant energy rises surface/subsurface temperature gradients and accentuates rates of surface temperature change ultimately contribute to stone breakdown through 'fatigue' effects. This absorption of energy reduces cohesive strength of intergranular bonds and initiates micro-fracture development, Figure 6 (b).

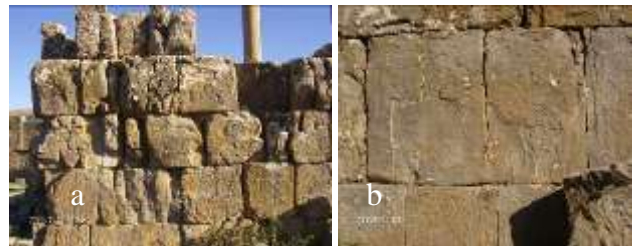
**Figure 7. Material loss and cracks**

In some part of the temple, masonry element were placed parallel to bedding planes of the rock (Figure 7 (a) and (b)) which causes cracks resulting from anisotropic behavior. It is evident that tensile load is higher perpendicularly to bedding planes whereas the strength of the material in the same direction is lower in tension.

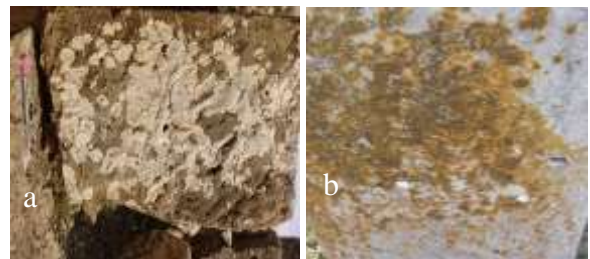
**Figure 8. White and orange lichens**

Moreover, as can be seen from Figure 8 (a) and (b), white and orange lichens cover a large part of the monument. Lichens discolor and adhere strongly to the surface of wall stones. Lichens covering occurs mainly in the northwestern sides sheltered from the sun. According to ICOMOS Glossary, [6] microbiological activity potentially results in biocorrosive and biooxidation activities due to the excretion of organic acids and the oxidation of iron-containing minerals. Additionally, biofilms might be of importance for thermal and moisture balance of the stone surface, thus indirectly affecting physical weathering processes.

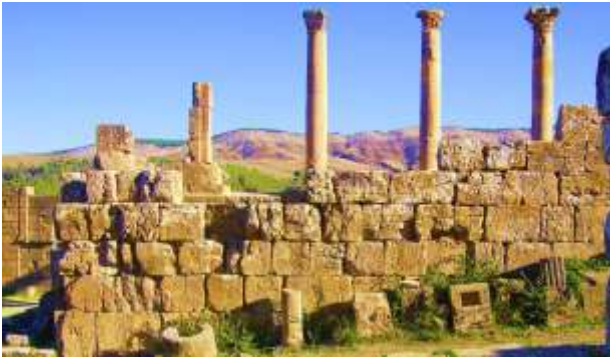
**Figure 9. Orange patina**

Furthermore, orang patina also occurs on the majority of masonry element of the temple, Figure 9. There have been controversial discussions about the origin of these orange films, [6-11]. Various mechanisms are assumed to be at the

origin of their apparition, namely the biological activity, in this case may probably be the major source of oxalate crusts.
