Environmental Auditing of the Solid Waste Sanitary Landfills in Palestine

Yousrea Ramadan and Yasumasa Tojo

Keywords - landfill, environmental auditing, waste management

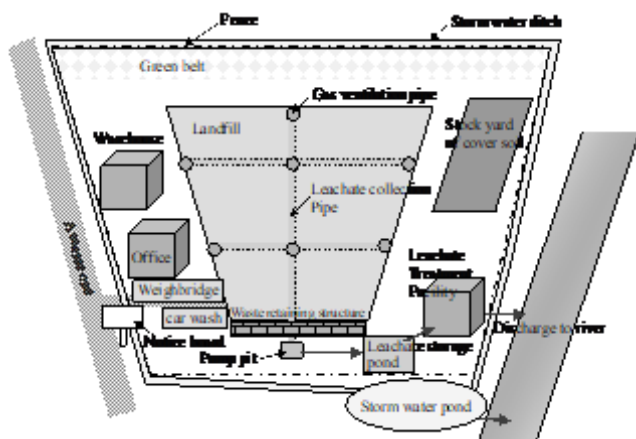
Figure 2. A basic infrastructure of the sanitary landfill. [2]

The environmental auditing process for any sanitary landfill is a kind of checking up on the functionality of the landfill and to secure its soundness from all aspects, such as design, operation, management, inspection, maintenance, and safety, which leads to formulate a clear picture for the operation and monitoring about the sanitary landfill status. The environmental auditing is expected to contribute to fix any failure in the landfill operation, and consequently the landfill continues functioning properly. The following items are required to be checked:

1. Site selection (proper site must be selected and vulnerable areas must be avoided)
2. Planning: Estimation of the quantity and quality of waste to be disposed of
3. Design: appropriate design and sufficient equipment's must be installed in the site (Fig. 2)
4. Construction: enough quality control of construction procedure

5. Operation: operation follows the standard procedure applied commonly
6. Management: proper management and maintenance of the facility
7. Monitoring: Every environmental component is monitored appropriately
