Suggestive Methods to Improve Illumination of an Opencast Mine to Safeguard the Safety and Productivity of the Mine

Abstract—The main objective of this study was to assess the illuminance level in mines at different strategic locations as mentioned in statutory circulars by the Directorate General of Mines Safety (DGMS). This paper highlights the detailed field observations for assessment of the existing lighting condition of a mine and to quantify the effect of poor lighting on the safety and productivity of different Heavy Earth Moving Machineries. The second part of the work was to find out inherent problems in the illumination system of mines and design of most suitable illumination system for the haul roads by using DIALux software. The safety and health aspects were also included in this study. There were three mines namely Mine1, Mine2, and Mine3 chosen for field observation. The safety status of different locations inside the mines was examined by comparing illuminance levels at those locations with what was set by DGMS and by various typical issues faced by operators in those mines. The illuminance level was measured using a lux meter present in respective mines. Illumina

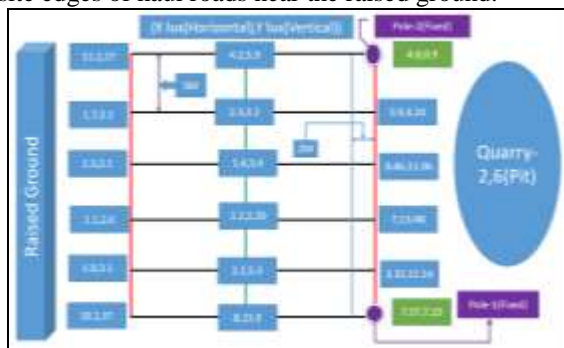
The reading was taken at 5m intervals along the length as shown in the illumination survey profile (Figure 1). The reading in line with a pole was taken at the end of the berm, which was on an average 2m from the poles. Readings were also taken on the middle of haul roads and along the opposite edges of haul roads near the raised ground.

Figure 1: Grid pattern illumination survey profile of haul road of quarry 2 & 6 in Mine1

The illuminance level was less than 10 lux in the central portion between the two poles. At the opposite edge of the haul road, the illuminance was more than 10 lux i.e., 11.2 lux horizontal and 27 lux vertical.

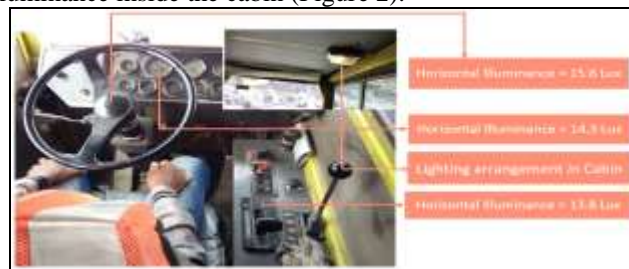
mines. Thus, it is extremely important to assess the level of illuminance inside the cabin (Figure 2).

Figure 2: Illuminance level at frequently used features of dumper's cabin

The horizontal illuminance at switches, gear lever, and speed meter was 13.8 lux, 13.8 lux, and 14.3 lux respectively. Horizontal illuminance at all the places inside the cabin should be more than 50 lux horizontal (DGMS_Metalliferous, 17). But nowhere inside the cabin, the value was more than 50 lux.

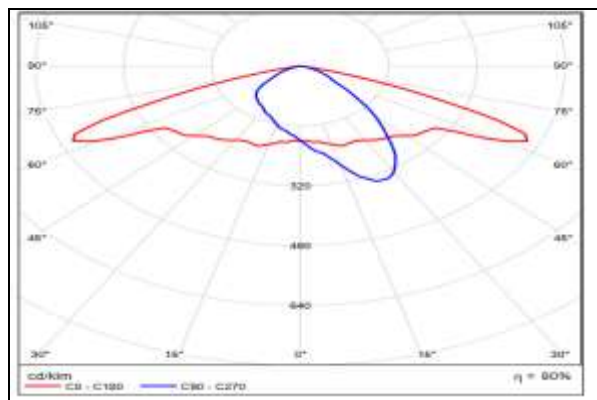
1. Spacing = 25 m
2. Width of Road = 12 m
3. Wattage = 240 W
4. Height of Pole = 9 m
5. Luminary Type = LED
6. Pole distance from Roadway = 1 m

Figure 3: Luminous Emittance Projection of the Selected Luminaire of Mine1

1. Light output ratio: 80.30%
2. Lamp luminous flux: 33200 lm
3. Luminaire luminous flux: 26661 lm
4. Power: 275.0 W
5. Luminous efficacy: 96.9 lm/W

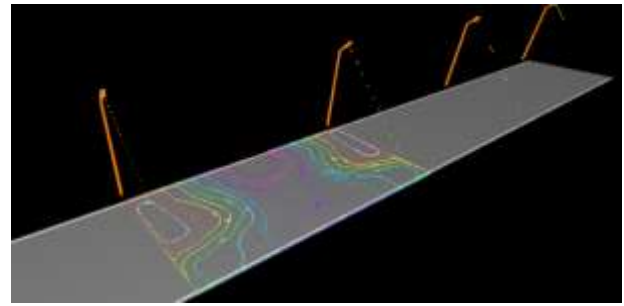
Figure 4: 3-D View of Haul Road with Luminary Parameter of Mine1

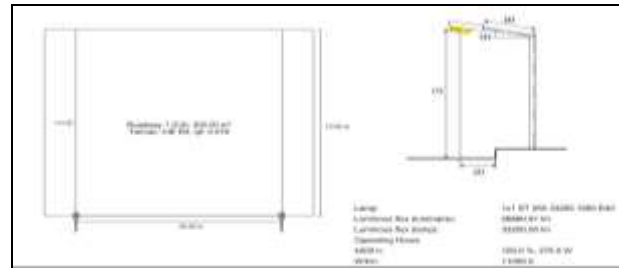
Figure 5: Luminaire Profile after Optimization in Mine1

The average illuminance level after optimization is 24.52 lux which is more than 10 lux values as set by the DGMS standard. The light loss factor was found to be 0.67 which is a significant portion of luminous emittance.

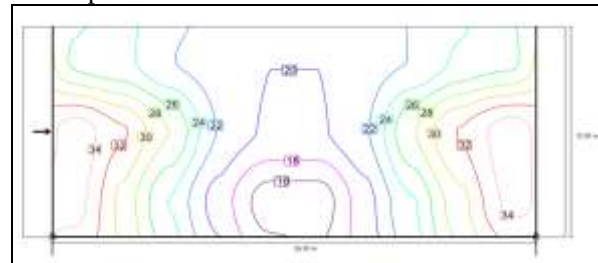
Figure 6: Isolux line showing horizontal illuminance in Mine1

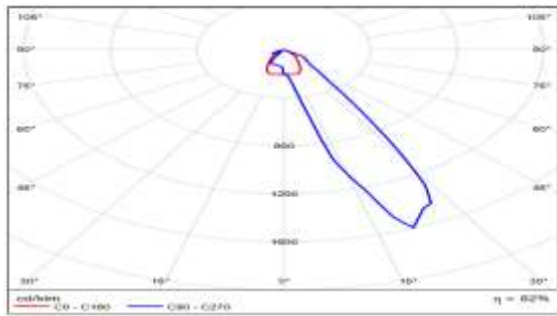
1. Pole distance = 30 m
2. Width of Road = 15 m
3. Wattage = 120 W
4. Light Centre Height = 8 m
5. Luminary Type = LED
6. Pole distance from Roadway = 1 m

Figure 7: Luminous Emittance Projection of the Selected Luminaire of Mine2

1. Light output ratio: 82.06%
2. Lamp luminous flux: 15000 lm
3. Luminaire luminous flux: 12310 lm
4. Power: 165.0 W
5. Luminous efficacy: 74.6 lm/W

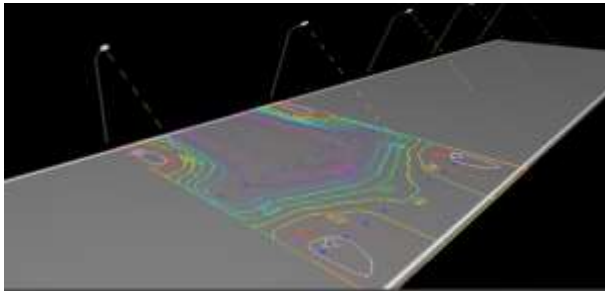
Figure 8: 3-D View of Haul Road with Luminary Parameter of Mine2

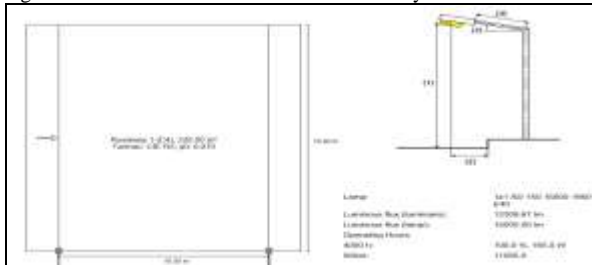
Figure 9: Luminaire profile after optimization in Mine2

The average illuminance level after optimization was 12.56 lux which is more than 10 lux values as set by the DGMS standard. The light loss factor was found to be 0.67 which is a significant portion of luminous emittance.

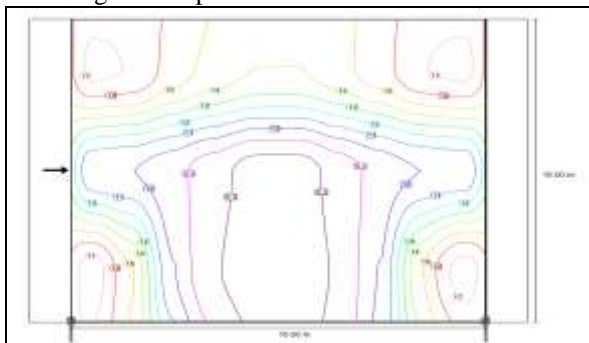
Figure 10: Isolux line showing horizontal illuminance in Mine2
