Causes of Filtration the Water in Roller Compacted Concrete Dams (RCC)

[J. O. Morandi, R. J. Uliarte, A. E. Carmona.]

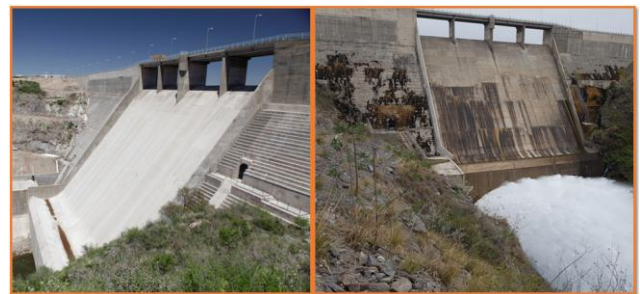
Figure 1. Photos. The dam presents the day of the inauguration, and five years later. There is upwelling of water on the wall waters down by leaks

through the body of the dam.

The Figure 1 and 2 shows the exterior and interior state of the dam.

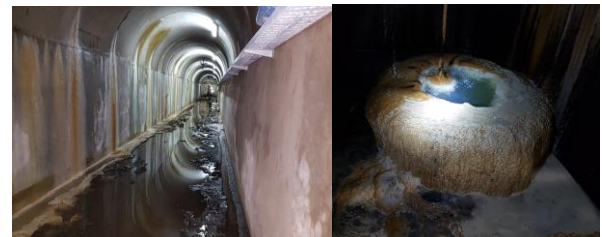
Figure 2. Photos. The interior of the dam is shown. Left a gallery of inspection and the inverted pendulum of auscultation system right. There is large amount of deposits of hydroxide of calcium leached from the body of the dam.

The water from the reservoir has no aggressive elements to concrete. However, the same occurs leaching of hydroxide calcium $[Ca(OH)_2]$ the RCC, in a process of progressive deterioration, which could compromise the security of the dam.

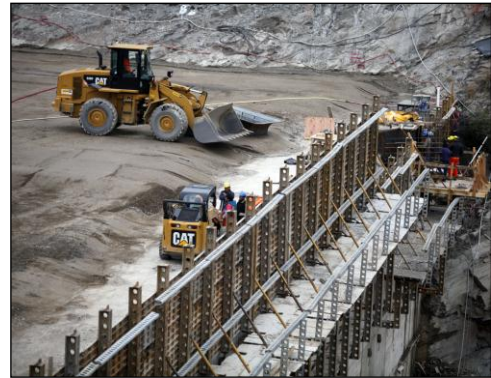
Compaction defect in contacts. If the layer of RCC is placed first and then that of CCV, cannot compacted and integrate both concrete. The order is reverse, first CCV should be and then the RCC to to integrate them. This error may cause a defect of compaction in the contact between CCV and RCC. It can be in the facing upstream, in the face of the waters below, in brackets, in construction joints (cold joints) by disruption of the placement of the concrete and in contact with pipes, ducts, and galleries.

This in turn leads to areas of high porosity and high permeability, which can operate as drains. These drainage

areas facilitate the draining of water through the dam and mask its travel.

Figure 3. The photo above shows an example in which being placed incorrectly, first RCC layer and then the facing CCV. The figure below shows an outline of the areas of defective compaction.

Figure 3 shows an example of this construction defect.

It establishes a network of flow complex in the body of the dam water that passes the Paramento is defective compaction zones (contact RCC-CCV- Figure3) longitudinally and transversely to the same through the area of compaction defective in RCC layers and horizontal joints between layers (Figure 5).

- c. It is strongly recommended to pay attention to the methodology of placement and compaction of the concrete, especially in the areas of contact between the RCC-CCV and the RCC with the rock of the Stirrups.

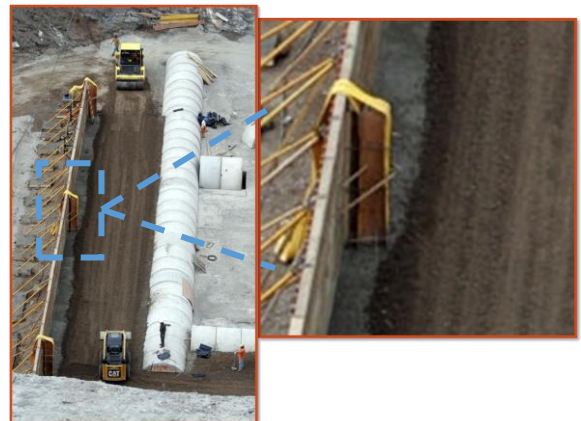
Defect of anchorage of the Joint Water-Stop. It is produced by a failure on the anchor of the Board with the HCV which also it is not compacted properly

Figure 4. Photos. Shows the lack of detail in the placement of the gasket water-stop.

- d. It is advisable to adjust, control and properly certify the proper placement, anchoring and sealing joints water-stop.
- e. Defects in concrete contacts with the rock of the Stirrups, also facilitate the flow of water, can seriously compromise the safety of the dam.
