# An Appraisal of Sandcrete Blocks Quality

## A Case Study of Katsina, Nigeria

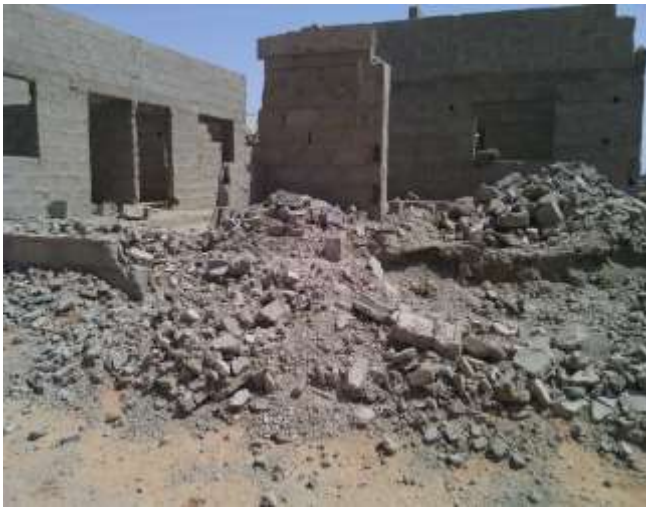
Plate 1: Collapsed Residential Building under Construction at Barhin Quarters

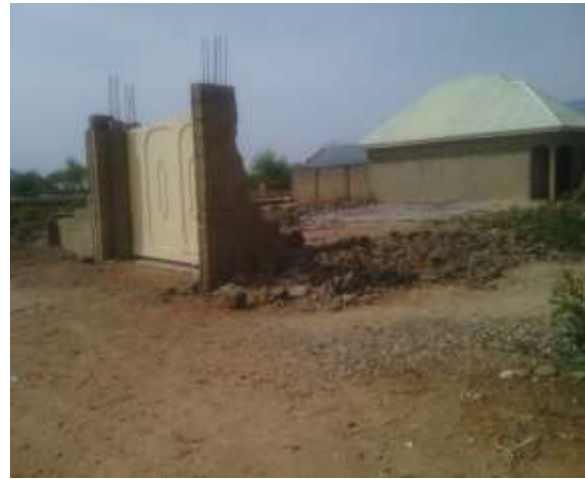
Plate 5: Collapsed block wall fence around Residential Building

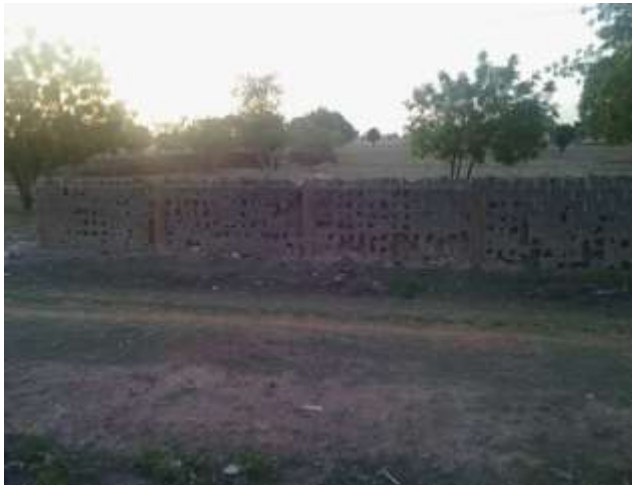
Plate 2: Wall built with poor Quality Blocks

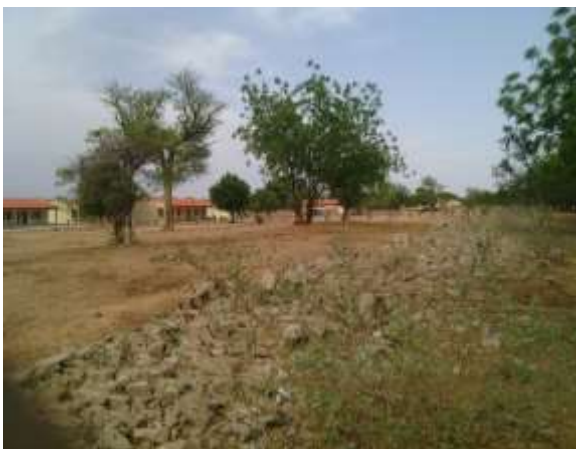
Plate 3: Collapsed block wall fence around public School
