# *Taoyuan Airport MRT EMU Vibration Prevention And Improvement Program Research*

**Abstract**—This study is based on the straight-line acceleration section and the occurrence of the jitter position on the operational routes, five sections are selected for the general survey, and then one section is selected for monitoring and analysis purposes. In addition, we try to find whether the corrugation phenomenon of the curved rail section affects the train or not?

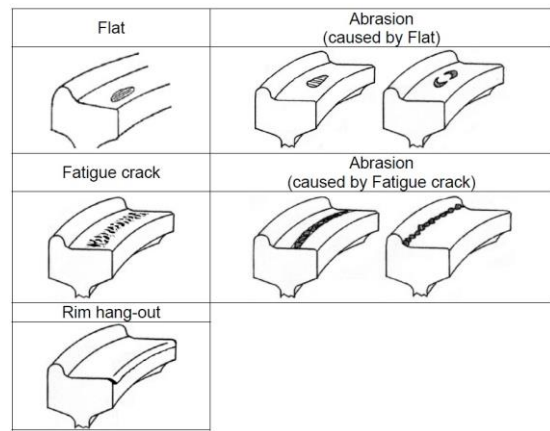
Figure 8: The main legend of wheel damage [7]

Because of this [6], the Taoyuan MRT route is tortuous, and the body is often deflected, which causes the wear arc of the steel wheel to be abnormal. In addition, during the turning process, the difference between the diameter of the steel wheel between the bogie and the bogie was ignored, and various factors caused the train to shake in the high-speed driving section. The flatness of the opposite rail tread will also affect the degree of wear of the steel wheel, so the damage of the steel wheel should be checked visually [7], as shown in Figure 8.
