Electrochemical Corrosion and Mechanical properties of welded AA 6061 joined by TIG and MIG welding methods

Aluminium alloy 6061 T6 circular specimens were joined using TIG and MIG welding methods. Heat Affected Zone (HAZ) and Base Metal (BM) were separated from each other. Potentiodynamic polarization and open circuit potential were employed to investigate the corrosion properties. Mechanical properties were evaluated using tensile, and hardness tests. It was shown that corrosion resistance was less for the HAZ of TIG and MIG welded specimens. The BM showed better corrosion resistance. The corrosion potential of HAZs was largely fluctuated; the corrosion potential for BM was relatively stable. Both welding procedures affected the mechanical properties of the specimens. The ultimate tensile strength of the TIG welded AA 6061 T6 specimens was 193.107 MPa which is 54% that of the base metal. The ultimate tensile strength of the MIG welded AA 6061 T6 specimens was 155.725 MPa which is less than 50% that of the BM. The HAZ of TIG welded specimens had the lowest hardness, for MIG welding the welded zone was shown to have the lowest hardness values due to the presence of pores which con

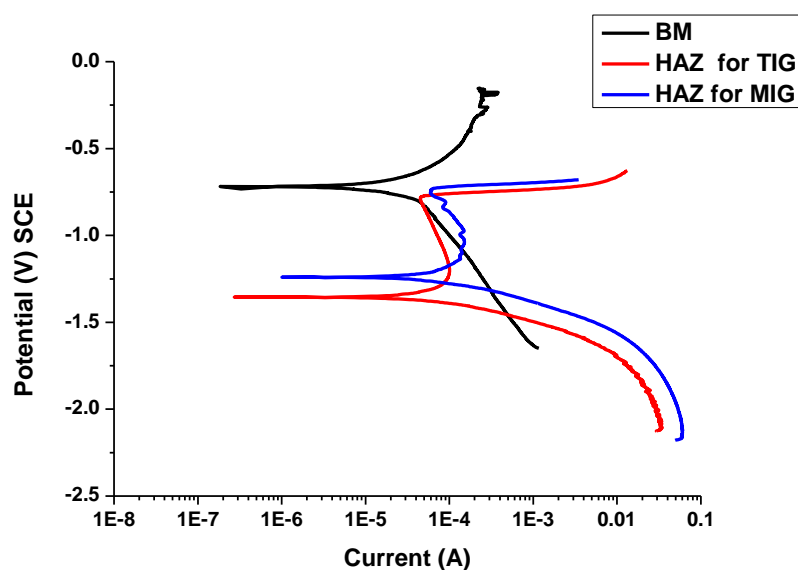
Figure 1 shows Tafel polarization plot for the base metal (BM) and the heat affected zones (HAZ) of both TIG and MIG welded specimens. The data that extracted from these plots are shown in table 3. It can be seen that the BM has a corrosion potential of -0.725V and a corrosion current of $24.02\mu\text{A}$. The corrosion potential for HAZ of both TIG and MIG welded specimens were -1.237V and -1.35V respectively whereas the corrosion currents were $82.44\mu\text{A}$ and $94.86\mu\text{A}$ respectively. Based on figure 1, it is apparent that the corrosion resistance of HAZ for TIG and MIG welded specimens was less than the BM. As can be seen from figure 2a and figure 2b, severe pitting corrosion of the HAZ occurred while on the base metal relatively less corrosion took place, this observation was attributed to the formation of dendritic structure with heterogeneous concentration distribution on the HAZ of TIG and MIG welded specimens [14,15] The extent of corrosion that observed on BM and HAZ is an indicating that the BM has a better corrosion resistance comparing to the HAZ (figures 2c).

Figure 1 Potentiodynamic polarization curves for TIG/MIG, and BM

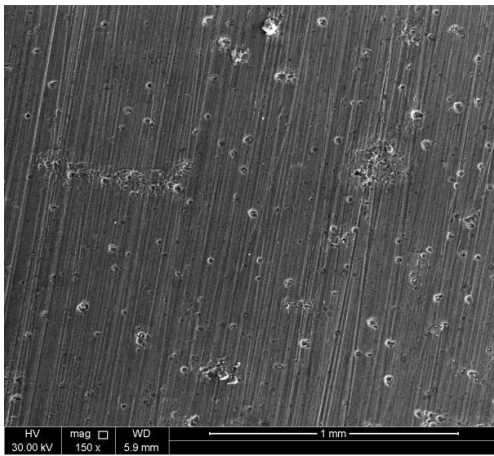
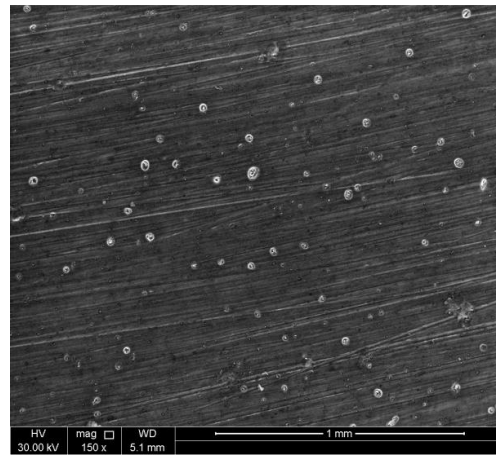
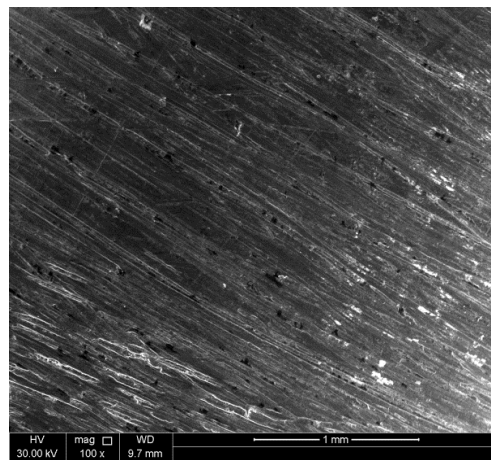
Figure 2 Extent of corrosion on a, and b: MIG welded AA 6061 T6 specimens, c: BM after immersion in 3.5% NaCl media

Corrosion potential usually depends on the electrochemical behavior of the elements that formed the alloy, this directly stem from the nature and quantity of the present phases. Coarse intermetallic particles enriched from iron and silicon lead to the dissolution of the matrix of these alloying elements. The ranking of solid solubility of various elements in the Aluminium matrix is: $Mg > Si > Fe$ [17]. Figure 4 illustrates a typical corrosion potential behavior for HAZ of TIG/MIG, and BM over a period of four hours, as can be seen the corrosion potential behavior of the HAZ for TIG welded specimens was relatively negative comparing to the HAZ of MIG welded one and the BM suggesting anodic behavior and consequently high corrosion rate [18-20]. The corrosion potential of HAZ for MIG welded specimens fluctuated largely with many positive and negative peaks reflecting poor corrosion resistance as a result of the alteration of the microstructure and corrosion properties due to the heat input during the welding process. On immersion, the corrosion potential of BM was around $-0.84V$ vs SCE then it was slightly fluctuated in the first 100 minutes. No big change was observed afterward. Based on the corrosion potential data, it is obvious that both TIG and MIG welding had affected the corrosion properties of the HAZ and caused it to be anodic with respect to BM and consequently more corrosion has taken place (figure 2 and figure 3)

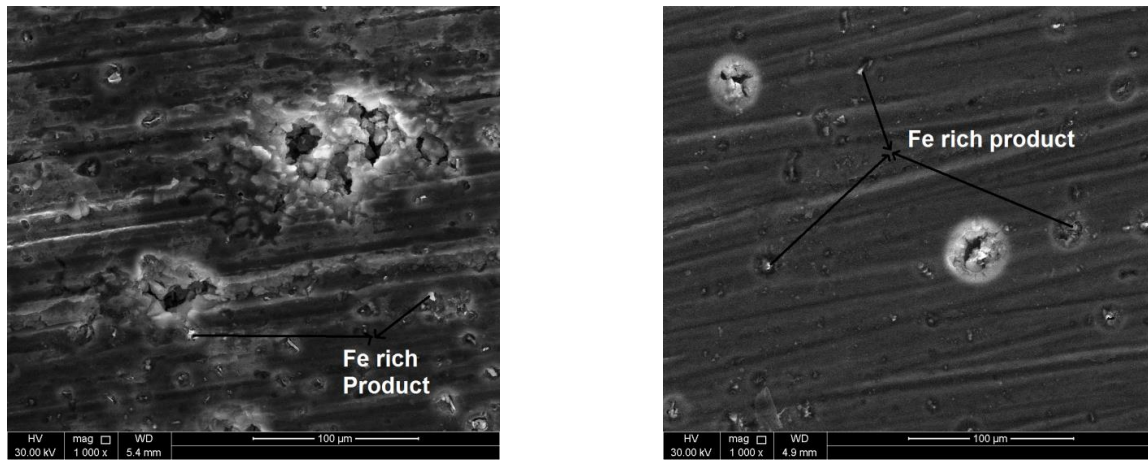
Figure 3 illustrates micrograph of surfaces of HAZ after potentiodynamic polarization test. It is clear that dissolution of Aluminium matrix has mostly occurred on the neighbourhood of the precipitates. This indicates that the coarse particles are cathodic with respect to the surrounding Al matrix. Examination of the coarse particles by EDS showed that it is Fe-rich. Because the composition of these particles are different from the Al matrix, a potential variations is expected between them. The cathodic reaction, typically oxygen reduction is expected to take place at the Fe-rich particles and the anodic reaction will take place at the Al matrix. The cathodic reaction usually generates OH^- ions which will increase the solution pH and accelerate the dissolution of Al matrix around these particles [16]. SEM observations for HAZ show that the specimens suffered from localised corrosion (figure 3). The morphology of the attack confirms that the coarse particles act as nucleation sites for pitting corrosion in areas adjacent to these particles while Fe-rich particles remained un-attacked.

Figure 3 Micrograph of HAZ for a: TIG welded specimen, and b: MIG welded specimen after potentiodynamic polarization.

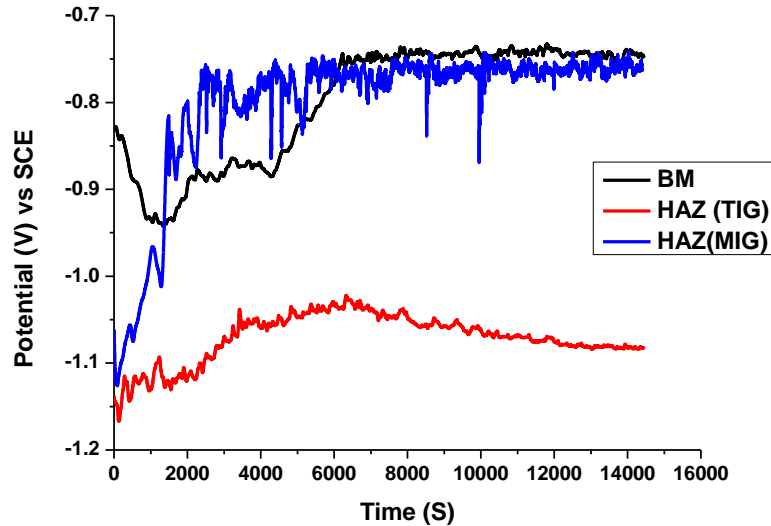
Figure 4 Corrosion potential of HAZ for TIG/MIG welded specimens and BM

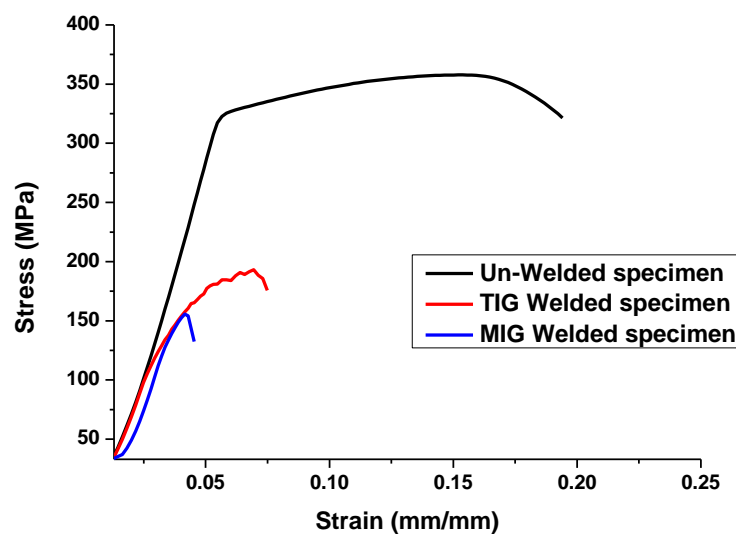
Figure 5 is showing the impact of welding on the tensile properties of AA 6061 T6 specimens. Based on figure 5, the tensile strength has declined significantly to less than 50% comparing to the un-welded specimens. The tensile strength for un-welded and TIG welded specimens was 357.747 and 193.107 Mpa respectively indicating lower mechanical properties for the welded specimens. It is reported in the literature that the welding process may leave some pores and defects on the welded area, such defects may cause some kinds of weakness in terms of mechanical properties which is the case in the current study. The utilization of SEM has clearly reveals the presence of some defects. Thus the welded zone is the weakest zone and consequently all specimens tested for tensile were failed at the same area.

Figure 5 Stress vs Strain for welded and un-welded AA 6061 T6

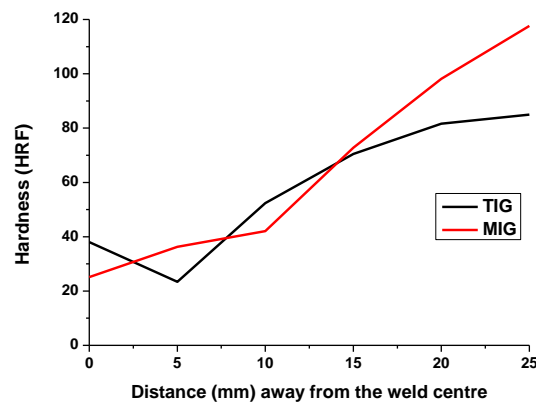
The results of the current study reveals that the HAZ of TIG welded specimens has the lowest hardness value recording 23.4 HRF at a distance of 5mm away from the weld centre (figure 6). Surprisingly the welded zone of MIG welded specimens has the lowest hardness value recording 25.13 (figure 6), this result is very interesting as it was expected that the HAZ may have the lowest value as in TIG method. The results found in this study encouraged us to further investigate the reason behind this observation; it was found that large voids were formed at the welded zone during the MIG welding process causing the welded zone to be brittle and have lower mechanical properties.

Figure 6 Hardness profile for TIG/MIG welded AA 6061 T6

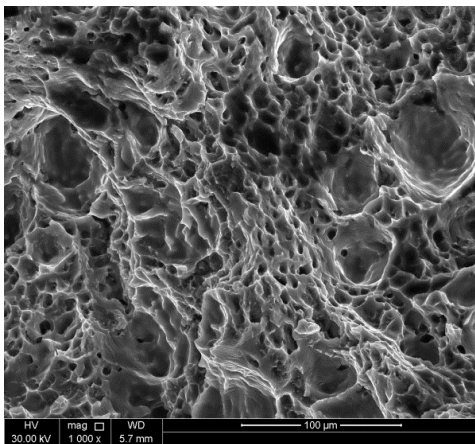
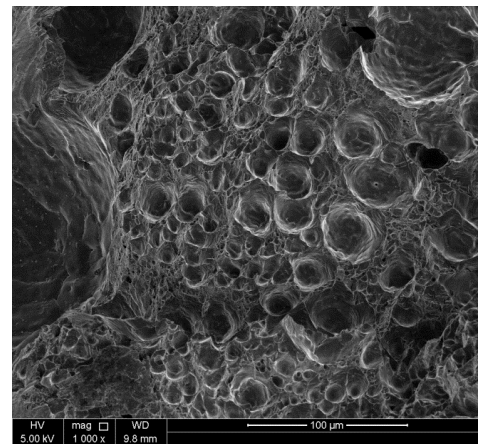
Figure 7 a shows fracture surface of TIG welded specimen, feature of ductile fracture is apparent, in addition to that, the size and the spacing between the grains produced at welded area were big which considered as an indicative of the ductility of the welded area. Based on fig 7 a, it can be observed that dimples dominated the fracture surfaces reflecting the fact that most of the failure was a result of a ductile fracture, this interpretation agrees with the work that done by many authors [21,22]. SEM fractograph of failed MIG welded specimens clearly reveals the presence of large pores and columnar dendrites within the pores (figure 7 b). The pores was distributed randomly over the fractured surface indicating poor mechanical properties [23].
