Phylosopy rehabilitation of Danube Croasing Pipelines

Timur Chiș, Robert Vlădescu, Marius Bănică

Keywords—Danube, croasing, oil, pipelines

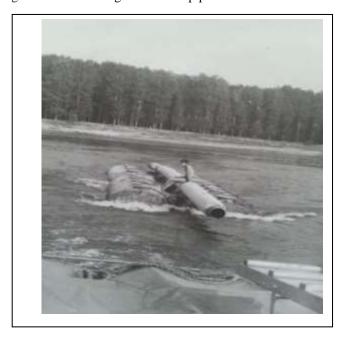
Figure 2. Danube croasing pipeline install

- a. dredging the bottom of the water (figure 1),
- b. treatment of pipes on the water surface (10 pipes of 300 mm) (figure 2),
- c. their ballast on the bottom of the water (figure 3).
